EVO: Wheels, Brakes & Tires - Sub-02R

Known issues with the 2004-2007 Style Rear Master Cylinder

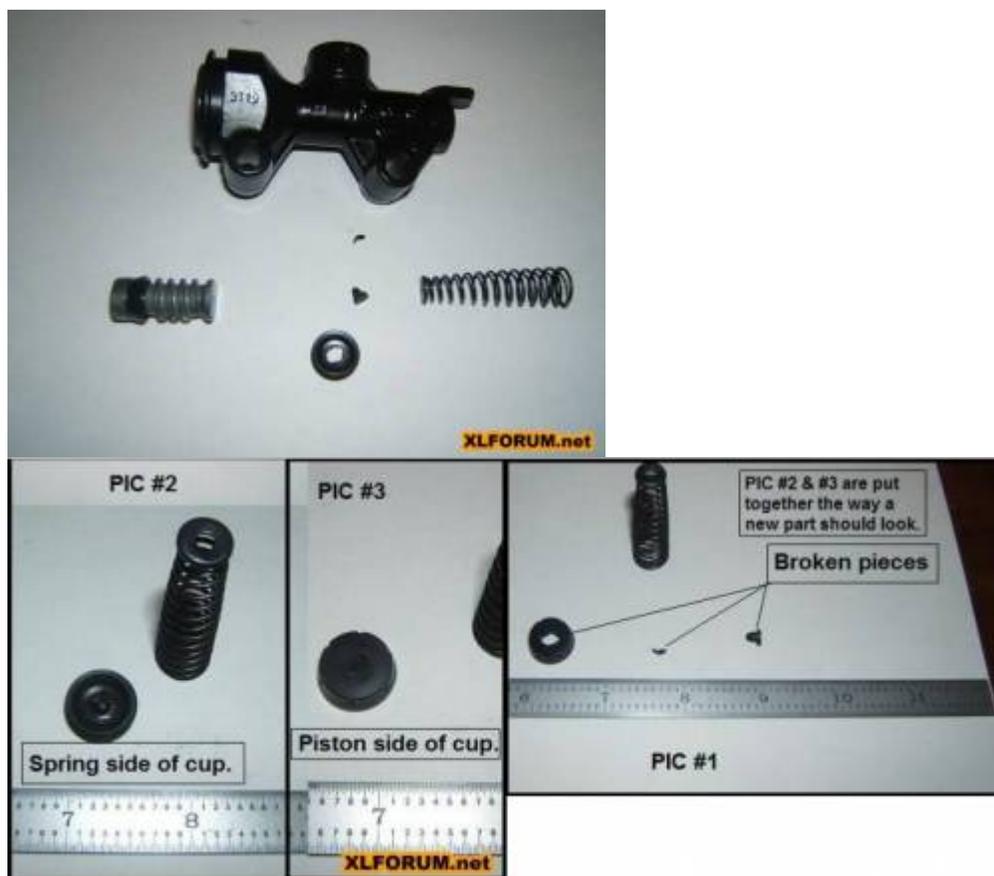
What seems to happen is that the primary cup gets torn in the center and it manages to still work as long as the MC is not disturbed much.

If you take the broken cup and the spring and hold them together on the bench, you will see that the washer can slide sideways quite a bit.

(within the center of the primary cup)

The tapered spring may try to cock some every time the pedal is pressed causing it to work against that tit until it breaks the tit off.

This leaves a split across the cup.

You may could try adding a larger washer on the end of the spring so that it will not keep fighting the tit for centering.

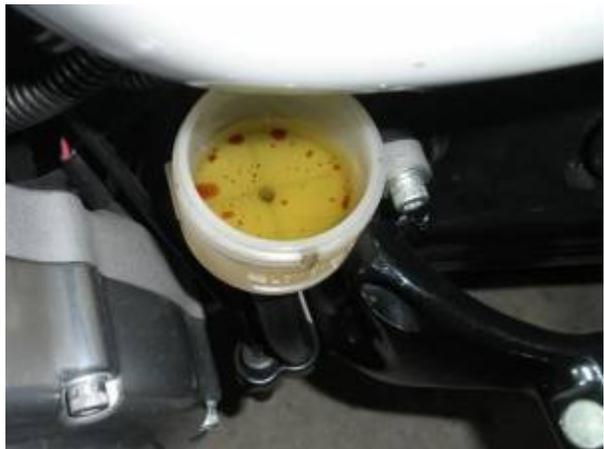
3)

This phenomena is still a mystery but it has been noticed repeatedly in the brake fluid reservoir especially in 2004-2006 Sportsters using DOT 5 fluid.

It has been said to look like a mixture with the appearance of Italian oil and vinegar dressing with an orange tint. ²⁾

One idea is that DOT3,4 or 5.1 might have been added to (top off) the fluid level.

But that would cause thick goop to drop out of suspension as the fluid would coagulate into thick gumps.
