MiscRes: Factory Recalls

This is a complete Factory Safety Defect Recalls (regarding Sportsters) from 1967-1979 of the MoCo's Motorcycle Safety Defect Recall Campaign. More will be added when found.

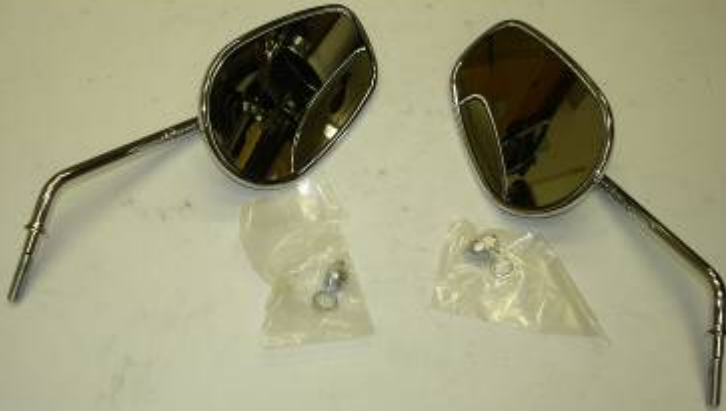
Mirror Kit (94190) for HD Safety Recall Code 0108
regarding 2002 XL1200C motorcycles

Right side mirror (91846-03), Left side mirror (91848-03)

Year Model	Recall #	Recall Date	TSB #	Subject	Sportster VIN Range
2002 XL1200C	0108	2003	M-1136	Mirror Kit	All 2002 XL1200Cs
<p>For Any XL1200C assembled/shipped from the Kansas City, Missouri plant equipped long stemmed mirrors (left 91902-88A and right 91904-88A). Certain 2002 model year 1200 Custom Sportster motorcycles have a condition whereby the left side mirror stem may fracture. This may allow the mirror to fall, possibly without warning, and present an unreasonable risk of accident, injury or death. In the interest of motor vehicle safety and customer satisfaction, HD elected to initiate a voluntary recall to replace both mirrors on all affected motorcycles with current production parts. See TSB M-1136 for dealer action required to perform the recall service.</p> <p>Click Here to go to the TSB page in the Sportsterpedia.</p> <p>Scroll down to bulletin M-1136, click on the "Y" in the chart to download the service bulletin.</p>

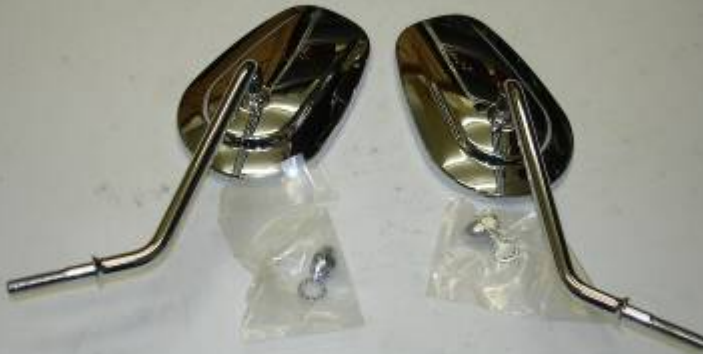
Mirror Kit (94190) for HD Safety Recall Code 0108
regarding 2002 XL1200C motorcycles

Right side mirror (91846-03), Left side mirror (91848-03)

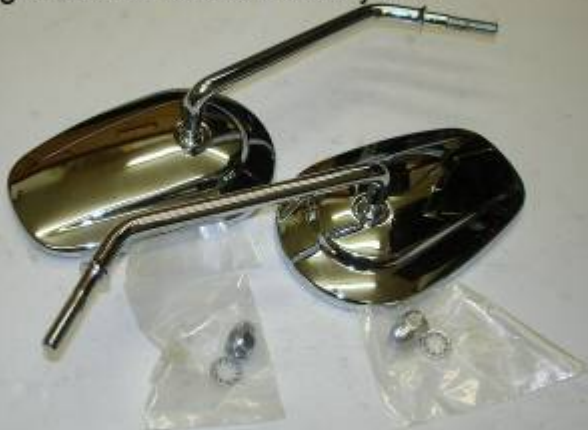
Mirror Kit (94190) for HD Safety Recall Code 0108
regarding 2002 XL1200C motorcycles

Right side mirror (91846-03), Left side mirror (91848-03)
