REF: Engine Mechanicals - Sub-01W

Aftermarket Lifter Issues

Roller Pin Manuf. Defect and Repair

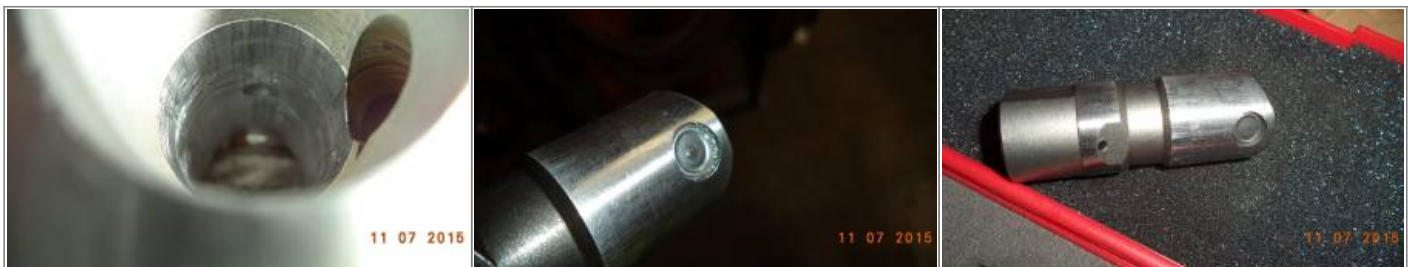
The lifter was cutting into the bore while installing them and turning them sideways.

The extruding sides were cutting on the opposite ends of the roller caps and gathering aluminum shavings in the pin hole recesses.

Upon measuring, the main body on this particular set of Fueling lifters were .903" on the main body with the roller end being .9035".

When the lifter roller pins (or pin caps) were pressed in, this process apparently warped out both opposite sides of the barrel ends.

The distance from side to side opposite the roller pin sides had a diameter of .0005" more than the main body.

The extruding part of the lifter base acted as a cutter on the lifter bore.

The company (when contacted) said they would replace them but with concerns of receiving the same issue with replacements, these were resized at the base.

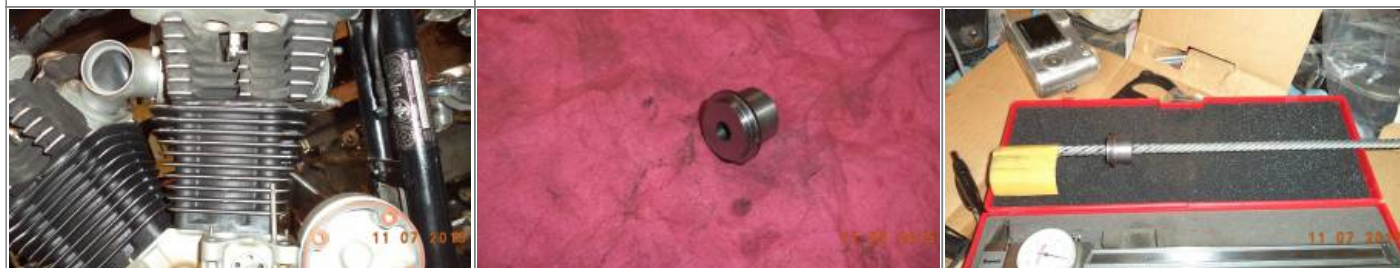
The bores are slanted toward the pushrod cup of each rocker arm. ²⁾

Homemade hone to lightly clean up the lifter bore. ³⁾

So the bore was honed slightly to remove the bulk of the scratches made by the oversized lifter end.

The hone was made from a ball hone with the balls removed and 400 grit sandpaper Gorilla glued to the shaft.

To keep center on the hone, a bushing was cut on the lathe with a slip fit hole small enough to accept the wire handle.

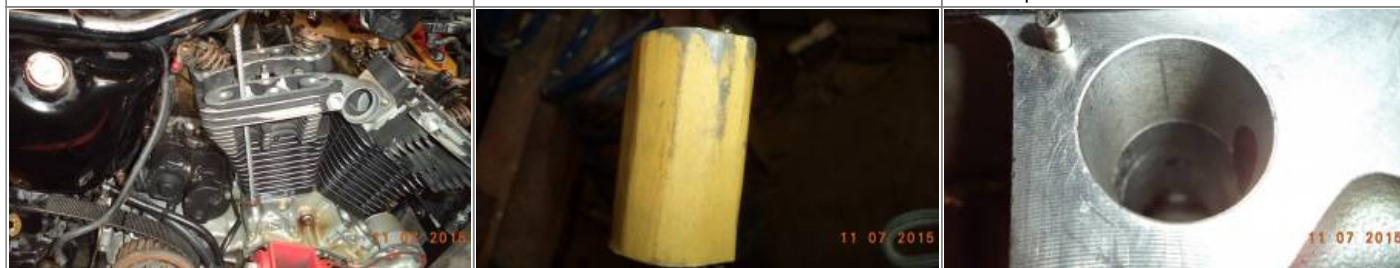
Hone held through center of pushrod hole. ⁴⁾

This is all that was removed from all 4 bores combined and from the bottom of the bores. ⁵⁾

All scratches weren't removed but honing too much would open the bore too far. ⁶⁾

The hone was turned by hand for app. 10 turns (while holding the bushing in place) per lifter bore to clean up the scratches.

Due to the slanted bores, the bushing was raised slightly while honing.
