## REF: Service Procedures 11C

# What Causes the 1991-2003 Shifter Detent Plate to Lean

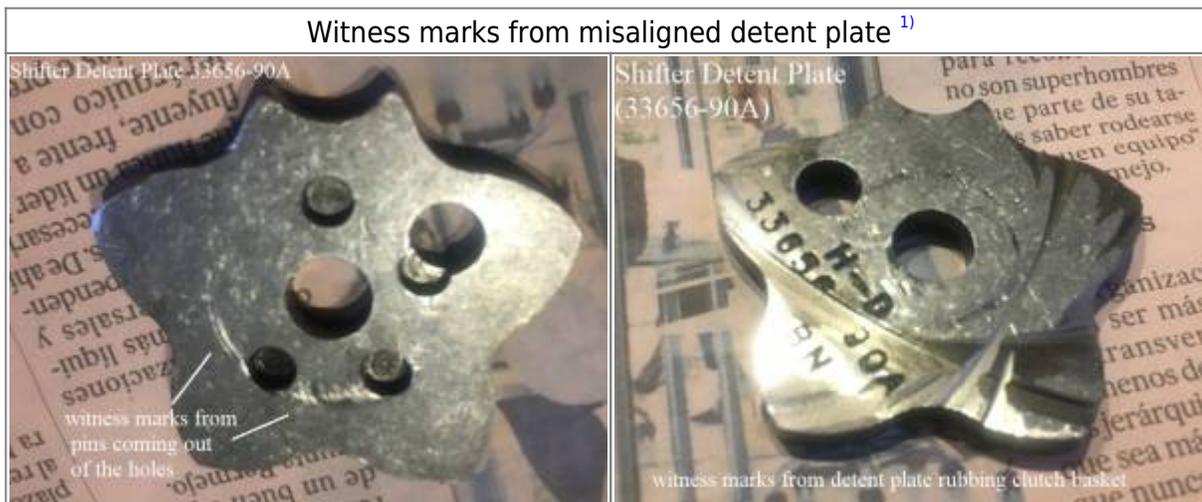
It's usually the shift drum pins walking out of their bore that leans the detent plate.

**Normally there is a clearance between the detent plate and the clutch basket / starter gear.**

And the detent plate roughly sits vertical to the starter ring gear.

The detent plates' vertical position is established by the length of the pins on the end of the shift drum. They should all be “home” and protruding the same length out of the drum (installed height .326” - .334”).

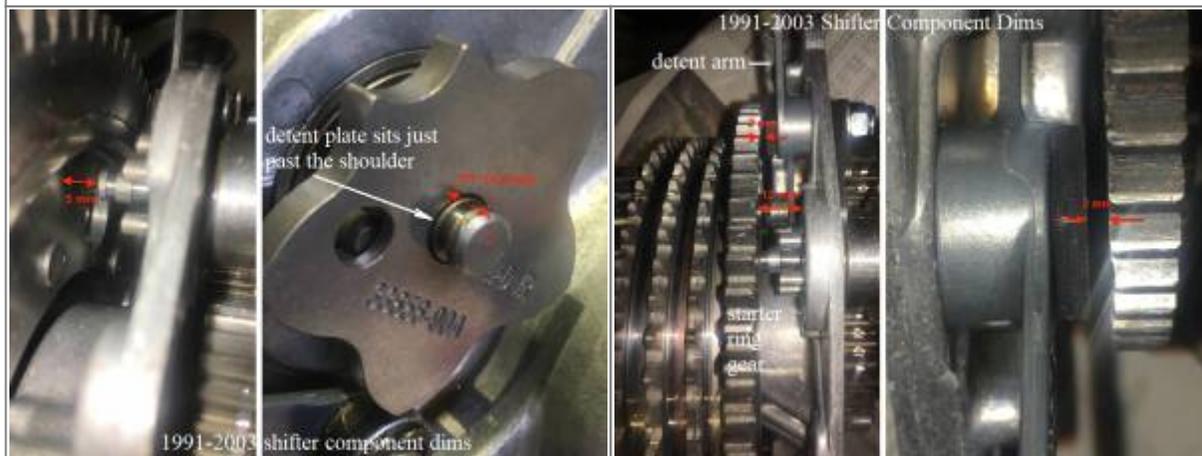
Dims taken from XLForum member, xLoneRiderx <sup>2) 3)</sup>

However, since the space is so small between the plate and the clutch basket, a skewed detent plate can make contact.

The designed "slop", adverse conditions and wear can easily make the detent plate "kiss" the back of the clutch basket.

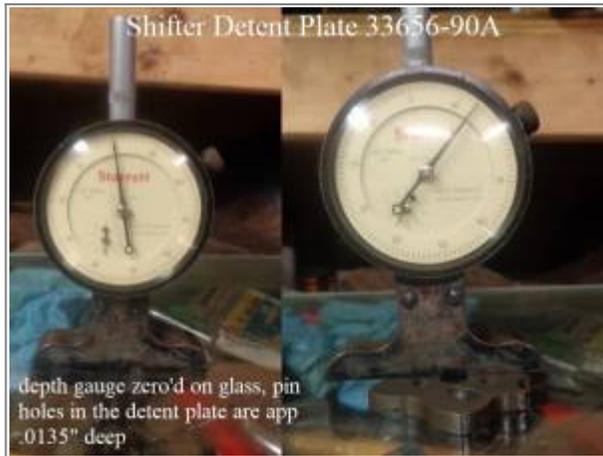
Detent plate pin hole depths <sup>4)</sup>

This "angle" pushing the detent plate can scar up the holes in the back of it where the pins go in. The retainer clip allows the detent to move far enough off the pins to slap the holes when the plate returns.

You may have noticed marring around those holes (which are not very deep to begin with).

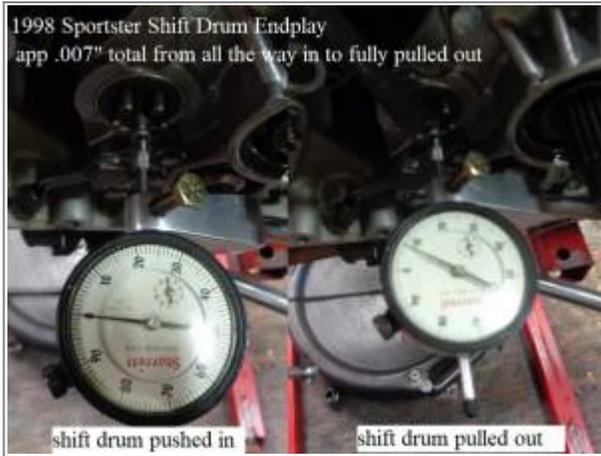
Shift drum end play <sup>5)</sup>

With the drum itself able to shift axially (app .007"), the distance between the detent plate and the clutch basket will be variable within that range.

So a leaning plate may have a touch / not touch situation if the space falls within that end play.
