## SHOP DOPE

No. 376 (Supersedes No. 356, which should be destroyed)

June 8, 1956

TRANSMISSION MAINSHAFT SECOND AND THIRD GEARS  
(This information applies to Models KH, KHK, and KHRM)

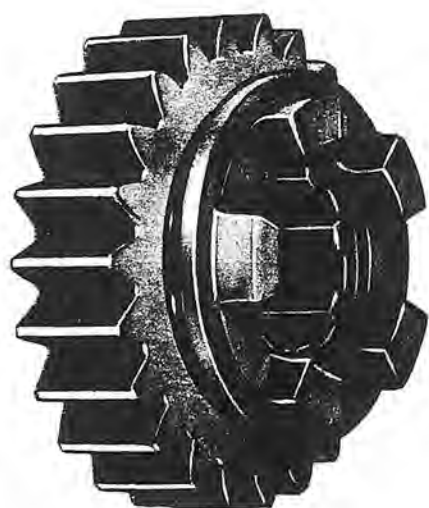
Part No.  
35296-56  
M/S 2nd Gear

Illustration shows new design M/S 2nd and M/S 3rd gears having 5 driving lugs and slots instead of 4. These new gears have been used in all 1956 KH transmissions, and from above date will be the only M/S 2nd and M/S 3rd gears supplied for servicing 1954-1955 KH transmissions, as follows:

These new gears, being much stronger than the design used in earlier transmissions, are to be used exclusively for future servicing of all KH transmissions. In other words, when either 35297-54A, 4 lug M/S 2nd gear, or 35304-54, 4 slot M/S 3rd gear requires replacement in a 1954 or 1955 KH transmission, gear set 35297-54B is to be installed.

- 1 35296-56 M/S 2nd gear, 23 teeth-5 lugs (replaces 35297-54A, 4 lugs)
- 1 35305-56 M/S 3rd gear, 20 teeth-5 slots (replaces 35304-54, 4 slots)
- 1 35337-56 M/S 3rd gear retaining ring (replaces 35337-52)
- 1 35364-56 M/S 3rd gear washer (replaces 35364-52)

Make an effort to service as many 1954 and 1955 KH transmissions as possible with the new gear set, especially new or used motorcycles on hand for sale, and those in the hands of rough operators. This preventive maintenance will pay off in less future service requirements.
