PRIMARY DRIVE CHAIN CARE - ELECTRA-GLIDE

**NEW DESIGN CHAIN FOR REPLACEMENT**

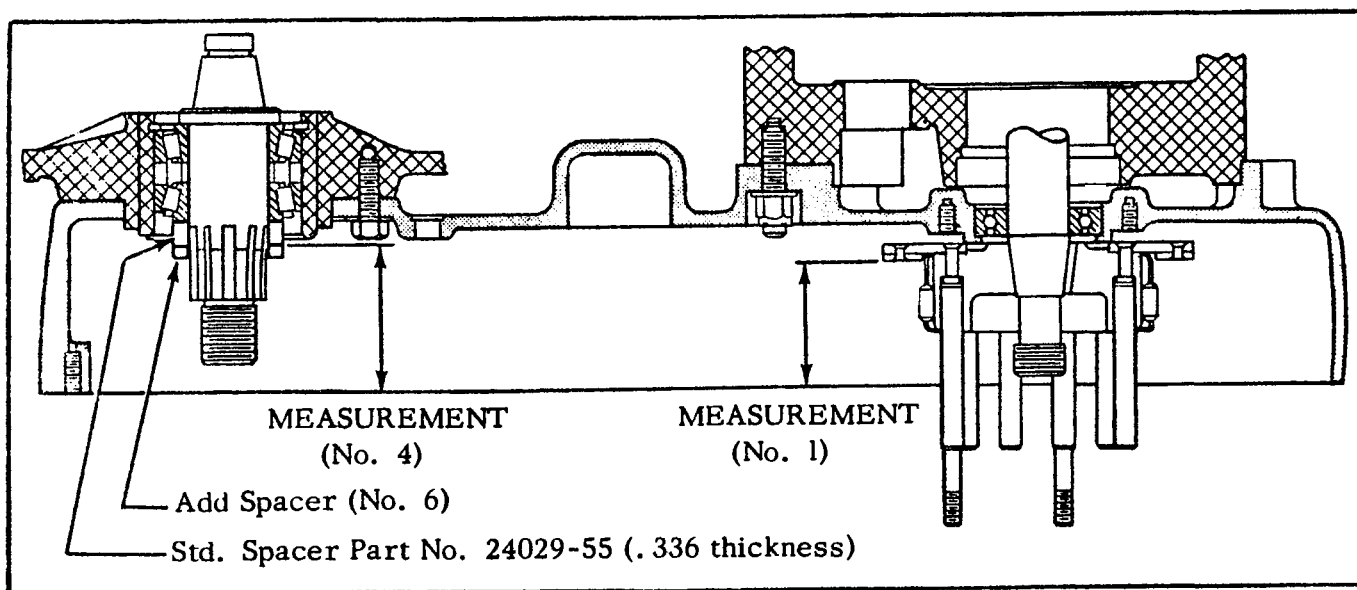
Premature chain wear can be caused by engine and clutch sprocket misalignment. Starting with 1966 season, changes to obtain better front sprocket adjustment were made in the Electra Glide model. These changes include new variable thickness sprocket spacers which can also be applied to 1965 Electra Glides. Whenever a new chain is installed on 1965 Electra Glides

With clutch disassembled from clutch hub and compensating sprocket disassembled from sprocket shaft as illustrated, determine spacer (6) thickness as follows:

be sure to get the correct front sprocket alignment using sprocket shaft spacers of correct width according to the following measurements.

In this case a .240 in. thick spacer would be added to existing .336 standard spacer to obtain chain alignment.
