MODEL HD CARBURETOR ACCELERATING PUMP CHECK VALVE

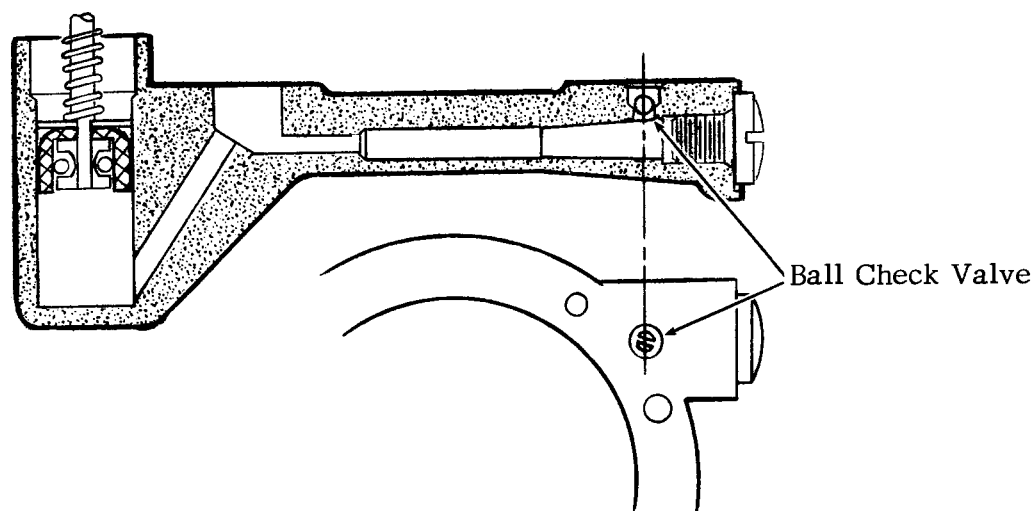
Late 1968 Sportster and Electra Glide Model Carburetors were recently changed to incorporate a ball check valve in the accelerating pump passage of the plastic cover. The illustration below shows the pump discharge passage and check valve, which provides a positive seal against air bleeding back from venturi into fuel chamber.

If air bleeds into fuel chamber through the accelerating pump passage, the following symptoms may occur:

- Poor or erratic accelerator pump action.
- Surging at cruising speeds accompanied by hesitation when rider attempts to accelerate from a given cruising speed.
- A "vapor lock" complaint when motorcycle is operated at low speeds after being operated at higher speeds.
- A tendency to stall when engine is idled.

Electra Glide carburetor, part No. 27160-66B, incorporating the new ball check valve, is stamped HD-2D or HD-2CD on the intake manifold flange.

Sportster carburetor, part No. 27162-66B, incorporating the new ball check valve, is stamped HD-1BC or HD-1C.

Pump body, part No. 27804-66A, now supplied for parts orders, has the new ball check valve and replaces part No. 27804-66, which did not have ball check valve.
