CLUTCH PUSH ROD AND THROWOUT BEARING — ELECTRA GLIDE

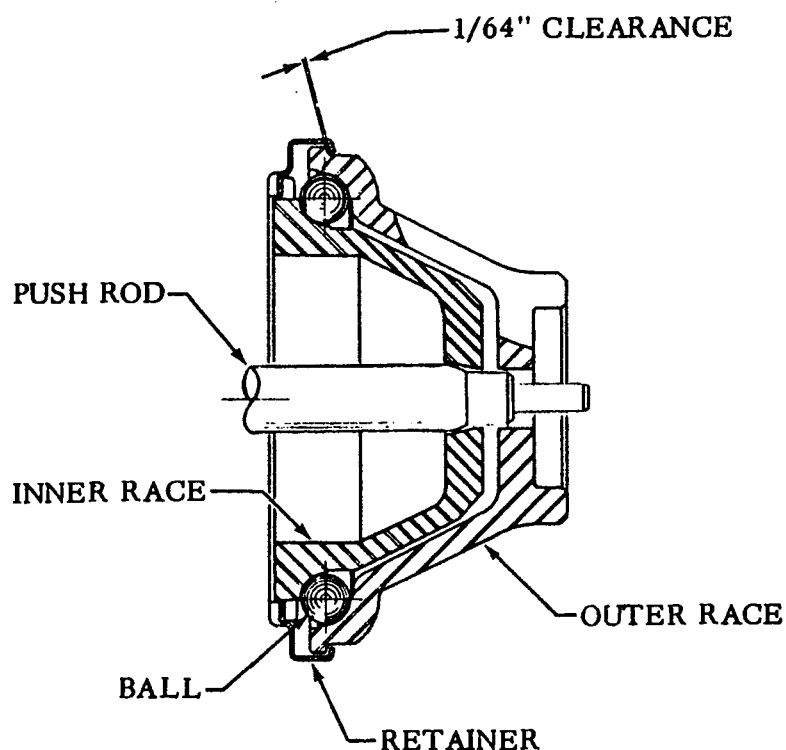
If clutch hand lever or foot lever free play increases thereby reducing the total clutch disengagement and it becomes necessary to make frequent adjustment, it is probable that the thrust bearing, part No. 37310-39 is not revolving freely, causing wear at the ends of the push rod, part No. 37285-65 or adjusting screw, part No. 37357-41.

If the above symptoms are present, it will be necessary to inspect the push rod thrust (throwout) bearing, since replacement of the push rod or screw only usually will not correct the cause for wear.

Disassemble starter (right side) end cover and check thrust bearing by laying on a flat surface, small diameter up and turn bearing while pressing down hard with the palm of your hand. If there is any roughness or binding in the bearing when turning, it should be replaced.
