CRANKSHAFT END PLAY / SPRINT

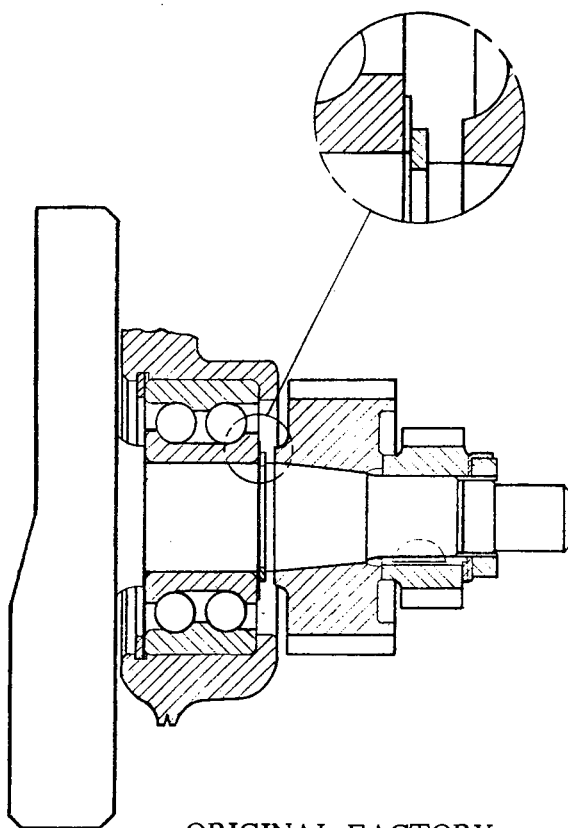
ORIGINAL FACTORY
SHIMMING METHOD

In some cases, the crankshaft endplay on Sprint engines has become excessive and the spacing shims used between the right side crankshaft bearing and shaft lock ring have pounded out possibly causing further damage to the engine.
