**GEAR CASE COVER OIL RELIEF HOLE / 1970 ELECTRA GLIDE**

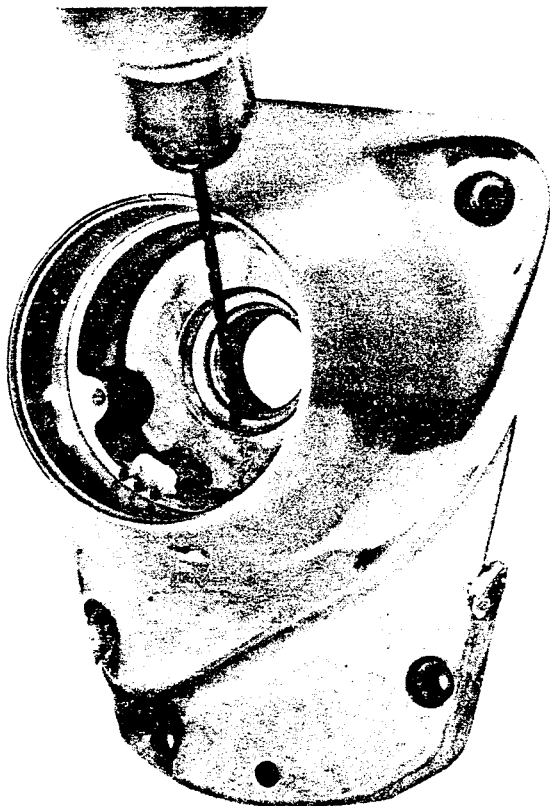
Set ignition timing according to procedure in Owner's Manual. Be sure to check circuit breaker point gap on BOTH cam lobes. If variation exceeds .002 in., correction must be made by checking for proper assembly of parts. Check advance plate assembly, Part No. 32629-70, for correct seating on end of camshaft. Interference between this part and camshaft end will cause the cam to tilt when center bolt is tightened resulting in unequal point gap. Correct by replacing plate or repair plate to provide necessary clearance as shown in the illustration below.

Chamfer edge and remove burrs from inside of recess in plate. Plate must seat flat against end of camshaft.

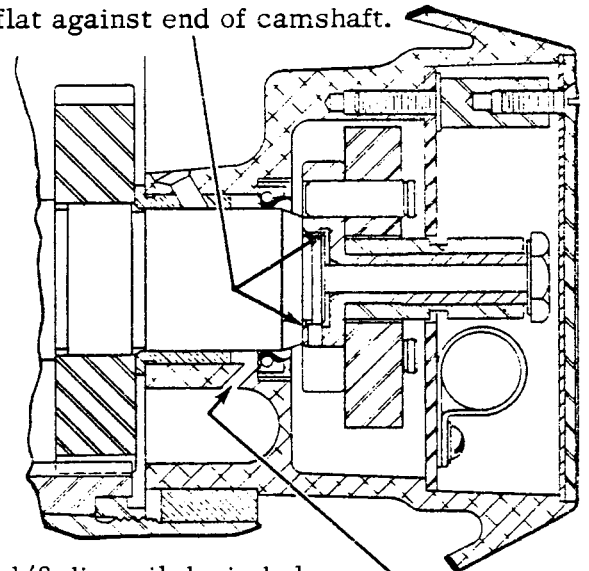
Starting with Electra Glide engine serial No. 12974, a hole has been added through the gear case cover flywheel shaft bushing boss to relieve possible pressure buildup in the pocket between the bushing and seal. In some cases, oil pressure buildup has caused leakage into the circuit breaker compartment or has blown out the lip type seal.

If desired, the oil hole can be drilled in gear case covers of engines below serial No. 12974 as follows: Remove circuit breaker cam bolt, breaker plate, advance assembly and gear case cover from engine. Remove oil seal from cover using a puller, or prying it out of recess. (A new seal must be installed when parts are reassembled.) Center punch and drill a 1/8 diameter hole through the aluminum boss, as shown in the illustration. Note that the hole should be located between the bushing and the seal. It should come out on the outside of the boss so that any accumulation of oil can drain from the recess between the seal and the bushing, then back into the gear case compartment. Install new oil seal and reassemble cover and circuit breaker on engine.

Drill 1/8 dia. oil drain hole.
