No. 614A

April 14, 1971

## 1971 ELECTRA GLIDE / SUPER GLIDE

CARBURETOR

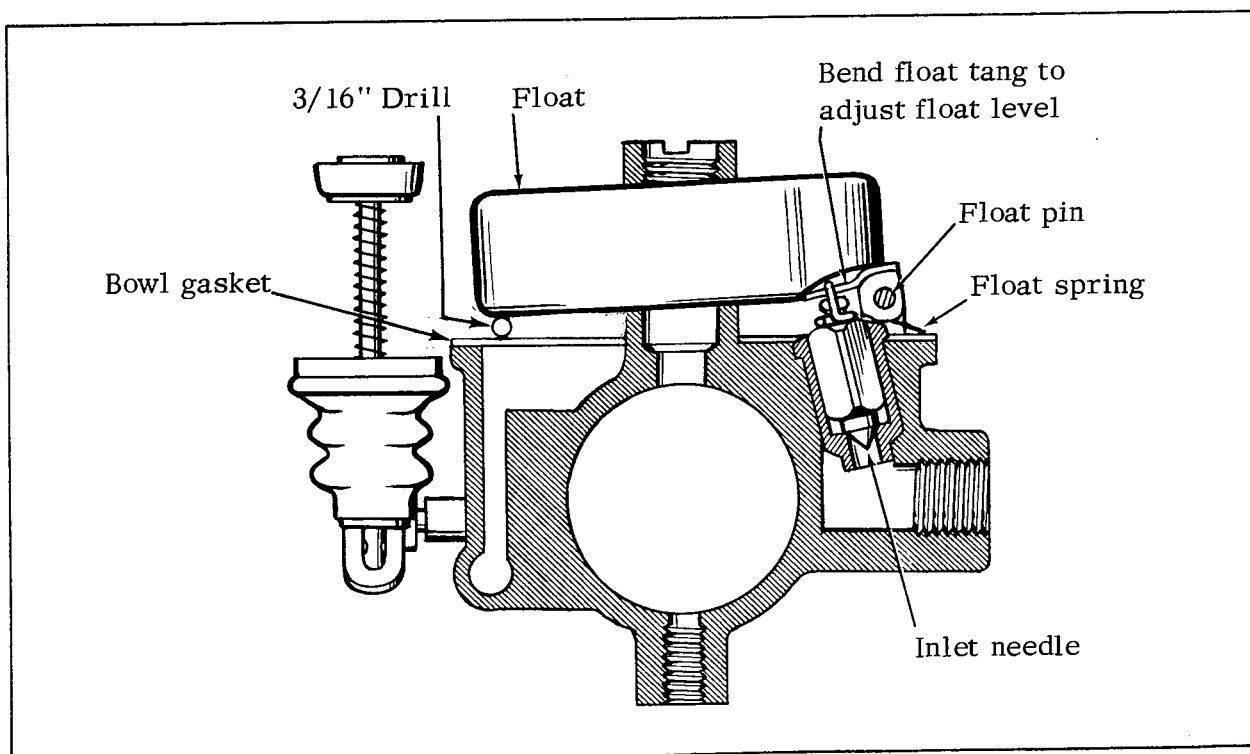
FIGURE NO. 1

Float setting changed from 1/8 in. to 3/16 in. to remedy a rich condition occurring at steady speeds. To correct, remove bowl nut and bowl. Hold carburetor upside down and measure height of float above surface of gasket with a 3/16 in. dia. drill as shown in diagram below. To raise float (results in lower fuel level), bend brass tang downward toward needle. To lower float, bend tang up. See Figure 1 following.

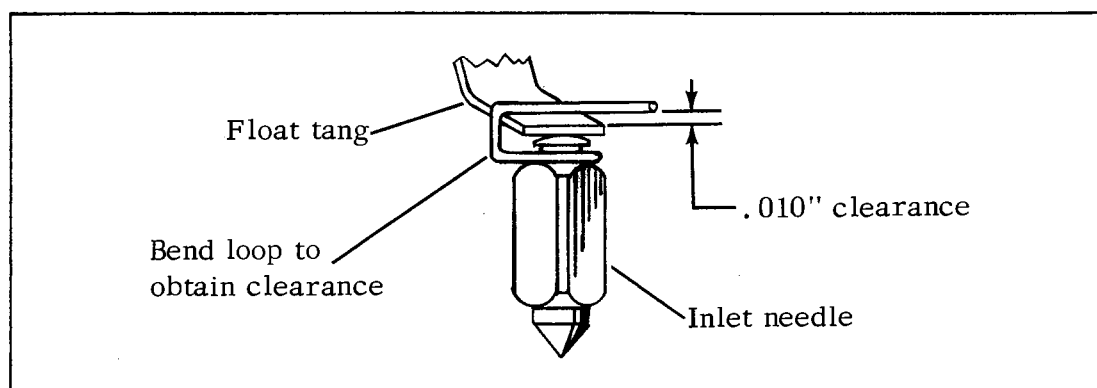
FIGURE NO. 2

Clearance between float tang and inlet needle wire clip decreased-should be .005 to .010 in. To correct, close up loop of wire by bending with a pliers as shown in Figure 2 following. Needle should operate freely with no bind when carburetor is held upright and float moved up and down.

Later carburetors have a bend in the upper leg of the loop.

Note: When assembling bowl to carburetor body, make sure long end of float spring presses against inside of bowl wall, and short end of float spring is hooked on float tang.

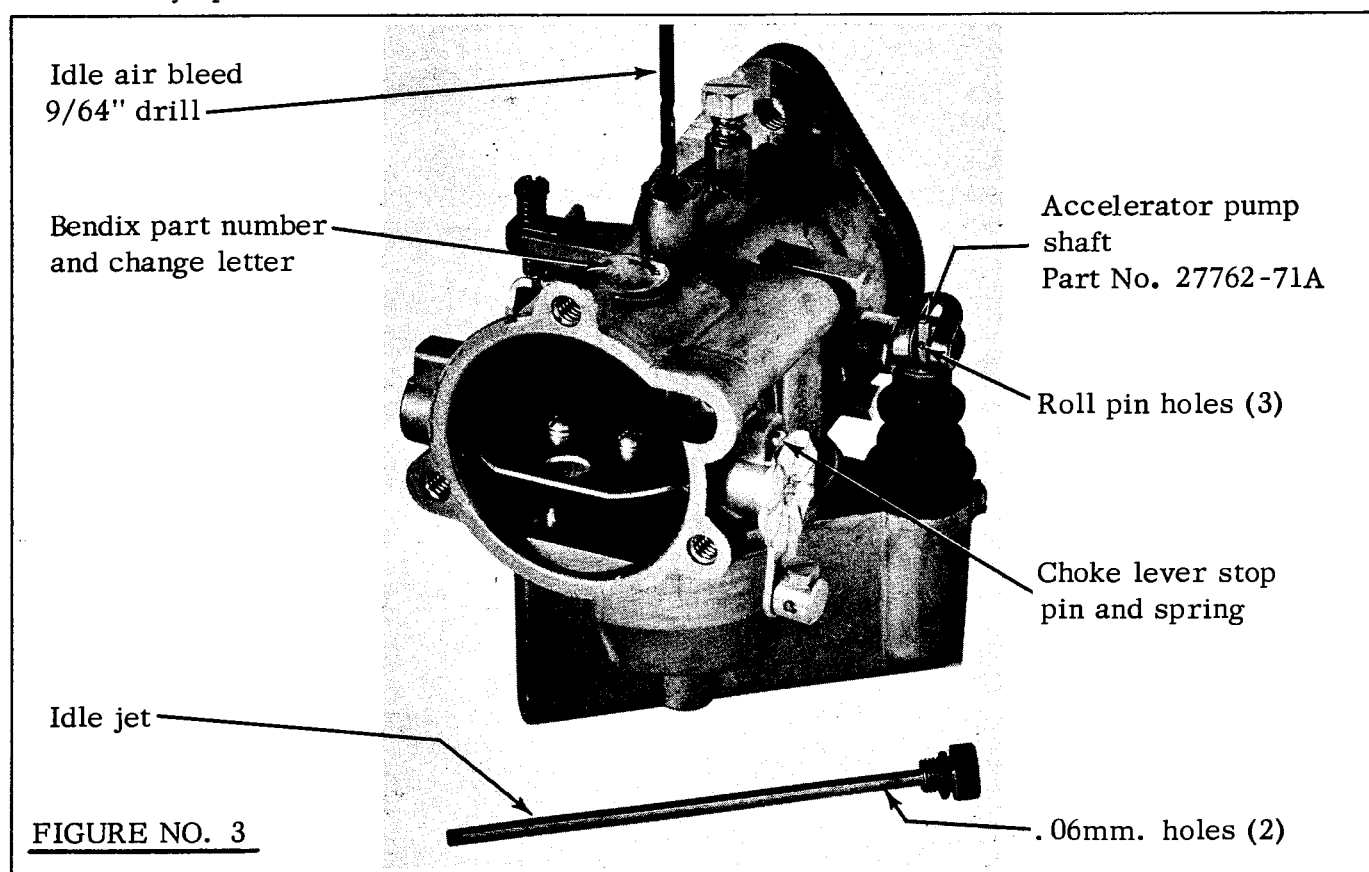
The letter A, B, C or D is stamped near the basic Bendix carburetor part number 13479 on the carburetor body boss for identifying carburetors with modifications. See Figure 3.

New carburetor choke shaft has detents with a spring loaded plunger engaging the detents to provide positive positioning throughout the choking range (See Figure 3).

New Part No. 27664-71 Choke shaft replaces 27664-70

New Part No. 27665-71 Plunger added

New Part No. 27666-71 Plunger spring added

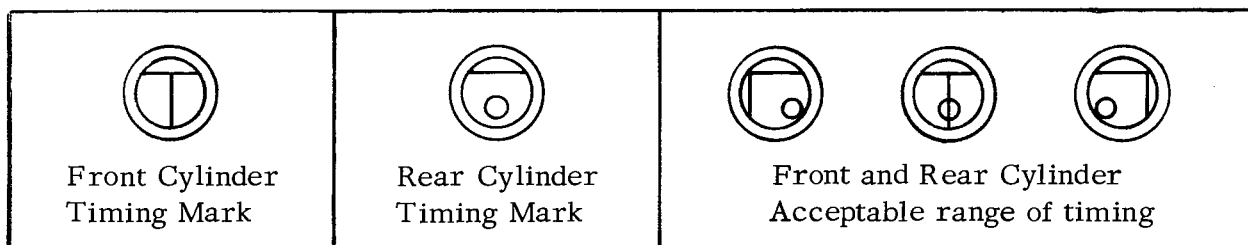
FIGURE NO. 4

Starting with the 1971 models, a rear cylinder ignition timing mark, a 1/4 in. dia. drill point hole, has been added to the flywheel so that both front and rear cylinder advanced ignition timing can be checked with a strobe timing light. With engine running at 2000 R.P.M., the front cylinder timing mark line should appear in the center of the hole with the rear cylinder timing mark dot appearing on or near the line. (See diagrams below.)

If both timing marks cannot be brought into view in crankcase inspection hole by shifting the circuit breaker base clockwise or counter-clockwise, check circuit breaker point gap to see that it is within .018 to .020 in. on highest point of both cam holes.

Correct any cause for eccentric cam operation so that point gaps will be within limits and then adjust breaker base to bring both timing marks into inspection hole with strobe timing light at 2000 R. P. M.

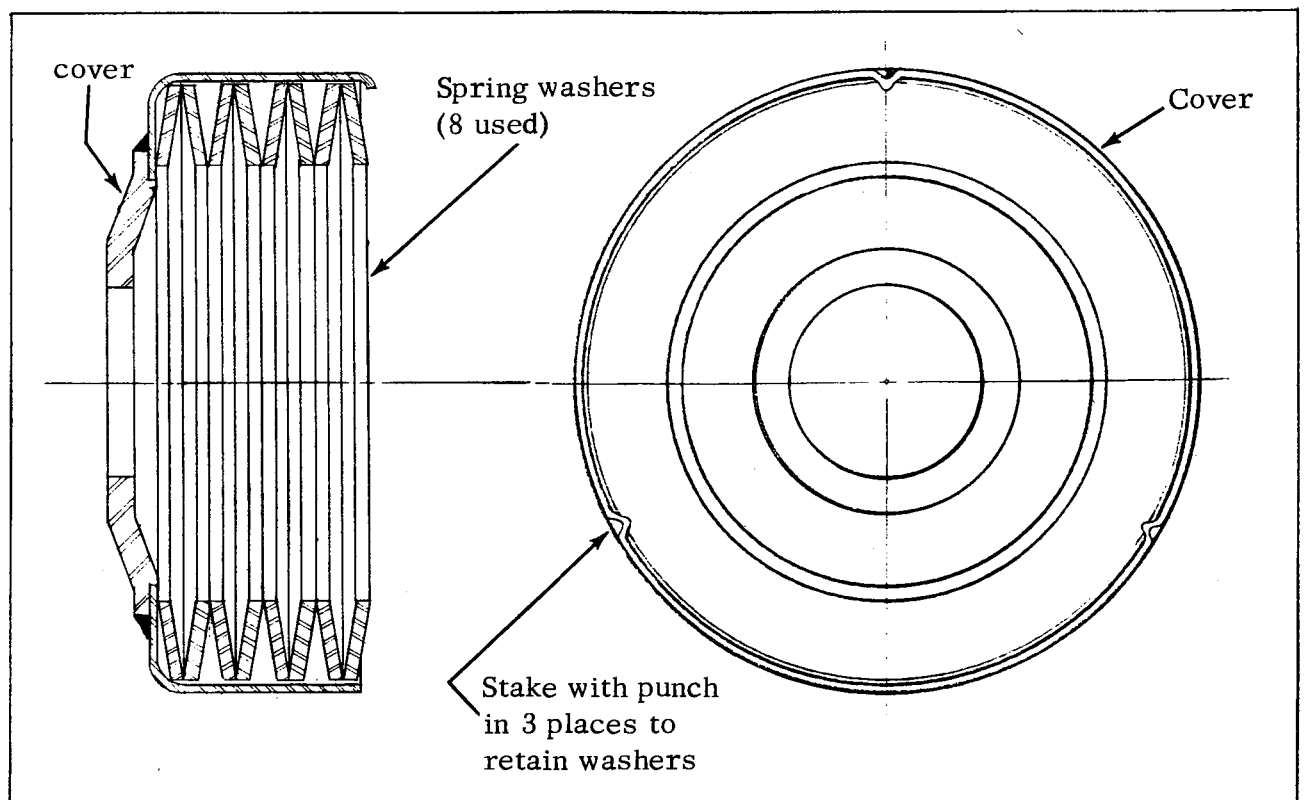
FIGURE NO. 5

The compensating sprocket spring cover thickness has been increased from .040 to .060 to strengthen against deforming. It is recommended that you install a new heavier cover, part No. 40385-70 on all motorcycles below VIN - 26758 H1. On very early production models also install new spring cup, part No. 40324-70 which is .840 in. high and replaces early spring cup which was .900 in. high. Compensating sprocket noise is an indication of loss of preload on the spring washers.

It is possible for this to be caused by worn cam surfaces, therefore cam should be checked first when disassembling sprocket.

To remove and install parts, remove primary cover, compensating sprocket nut and spring assembly. To remove springs from cover, bend staking open in 3 places with a vise grips so that 8 dished spring washers can be removed. Inspect washers and if damaged, replace with new ones, or replace entire assembly part No. 40324-70. Before installing 8 washers in new heavier cover, remove sharp edges from outside diameter with emery cloth. Install washers in the cover exactly as shown in following figure and stake cover in 3 places as shown.
