SPROCKET SHAFT BEARING/ELECTRA GLIDE, SUPER GLIDE

HARLEY-DAVIDSON MOTOR CO., INC.

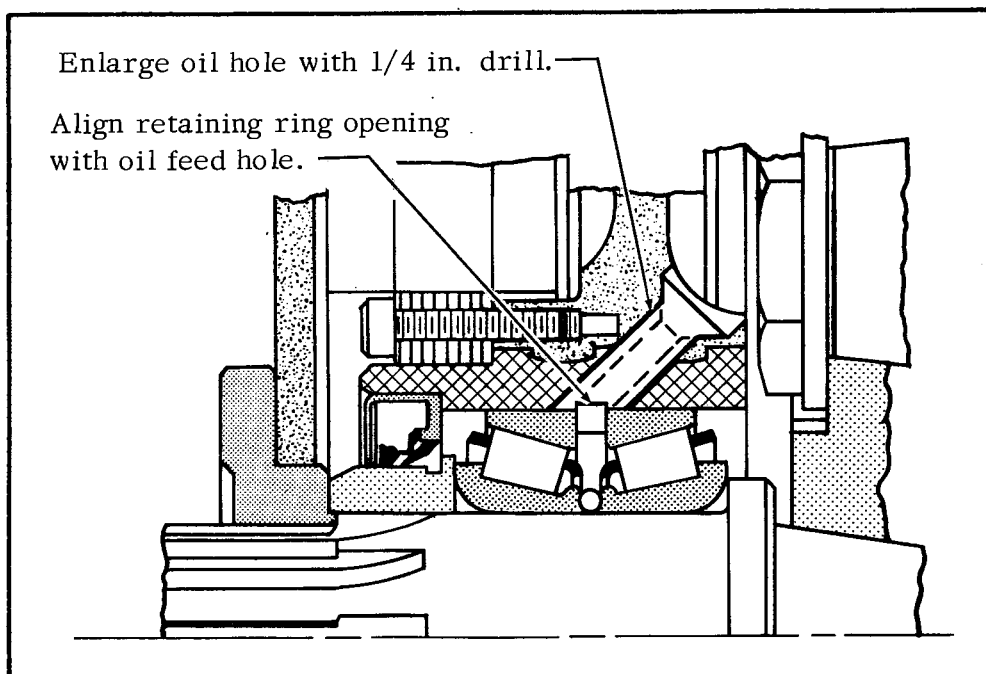
The crankcase oil hole which lubricates the sprocket shaft Timken bearing has been increased from 3/16 to 1/4 in. on late 1972 FL, FLH, and FX engines. Also, minimum end play has been increased from .0005 in. to .001 in.

See that retaining ring gap is positioned at oil hole as noted in the illustration.

Any time that an engine is disassembled for repair, these changes are recommended to improve bearing life.

It will be necessary to remove sprocket shaft bearing, races and retaining ring in order to drill out the hole with 1/4 in. drill. Sprocket shaft bearing end play should be checked with a dial indicator to maintain between .001 to .006 end play according to service manual procedure.
