1973 MODEL SS / SX

This bulletin contains important information on the 1973 SS-350 and SX-350 which you should be aware of. Recommendations herein should be followed to prevent or remedy possible service complaints on these models.

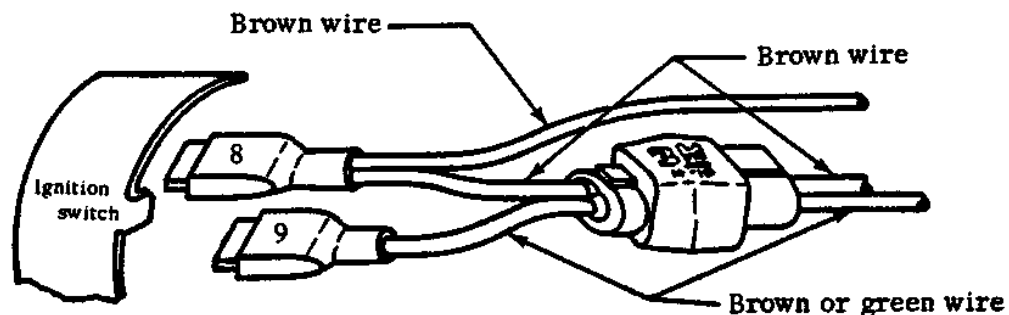
We have received reports of difficulty in keeping the battery at a sufficient level of charge to efficiently operate the electric starter. The following procedures will help in correcting this problem.

- c. If motorcycle will be operated primarily without the headlamp on, an appreciable increase in charge rate can be obtained through the following procedure. Remove the chrome plated retaining nut from the ignition switch and release the switch from its mounting bracket. With a white "Scotchlock" wire connector, Part No. 70576-68, connect the single brown or green wire on Terminal (9) to one of the two brown wires on Terminal (8) (See sketch). NOTE: If blue or red "Scotchlock" connector is used, remove wire stop to permit both wires to pass through connector.

The above modification provides full alternator output with ignition switch in lights-off position as well as lights-on position and should only be used if there is a chronic under-charged battery condition.
