TAIL LAMP WIRING /1973 MODELS XL,XLCH,

AMF / Harley-Davidson Motor Co., Inc.

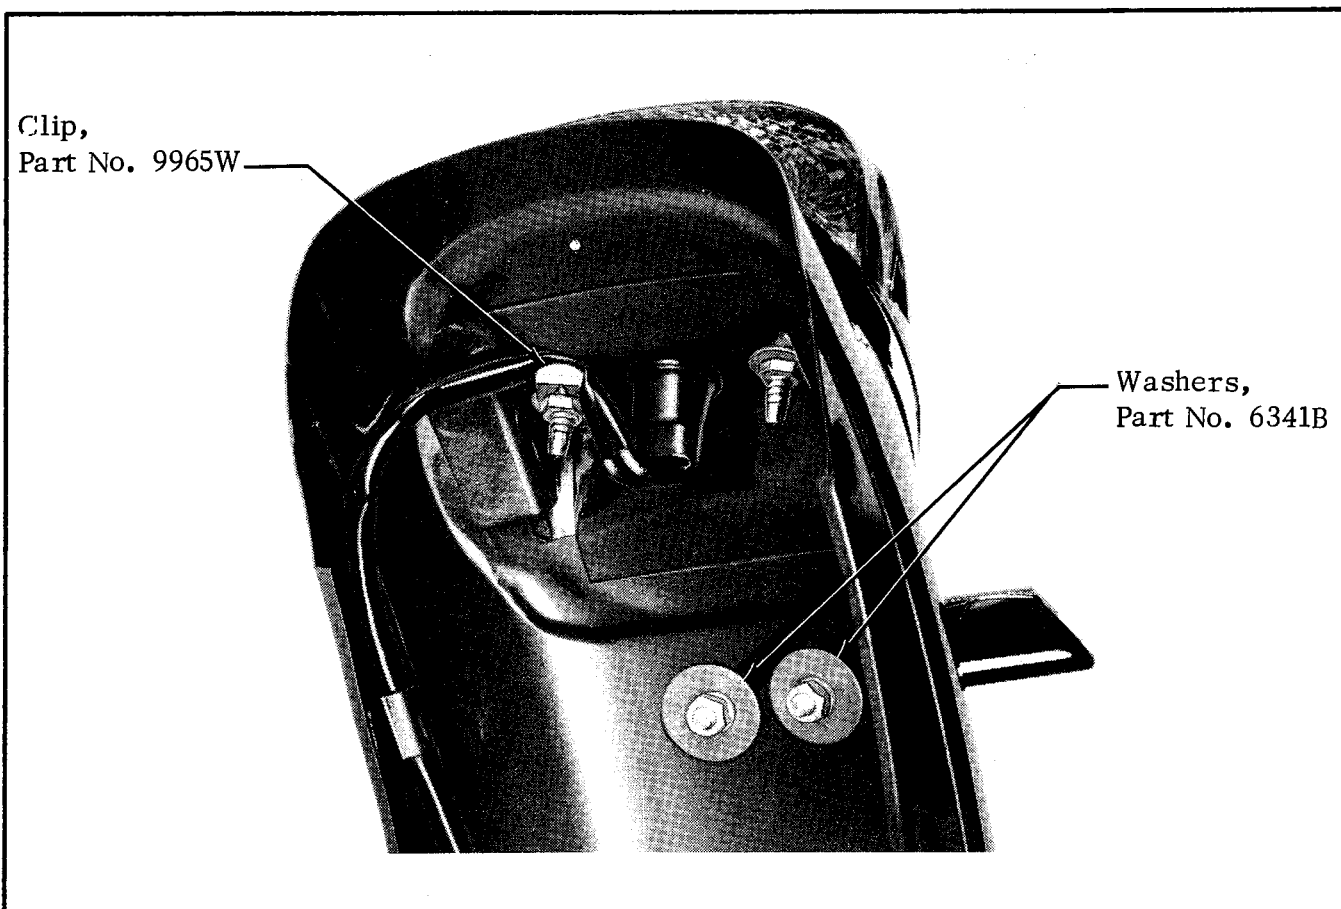
Initial production of 1973 Models XL/XLCH-1000 motorcycles were produced without a retaining clip to hold the wires against the fender near the tail lamp bulb socket.

This condition allows the wires to loop outward into the tirewell, possibly contacting the tire and rubbing off the insulation or tearing the wires when the wheel is adjusted to the rear position.

Removal of the wire insulation or tearing of wires would result in a short circuit or open circuit making the tail lamp and/or stop lamp inoperative. This would constitute a traffic hazard because of the absence of a stop signal and/or tail lamp illumination to warn following traffic.

Rear Tail Lamp Wiring Clip and License Plate Mounting Washers

In compliance with the National Motor Vehicle Safety Act, this has been declared a safety defect and will require that you install retaining clip, part No. 9965W, on the left side tail lamp mounting stud of all affected vehicles, to hold the tail lamp wires in place (see illustration).

Note: At time of vehicle inspection, check to see that 1-1/8 dia. flat washers, part No. 6341B, are installed underneath license plate bracket nuts as shown in the illustration.

These washers have been added for later 1973 production to reinforce the bracket mounting.
