## IGNITION SWITCH / 1974 FX, FXE, XL, XLCH

HARLEY-DAVIDSON MOTOR CO., INC.

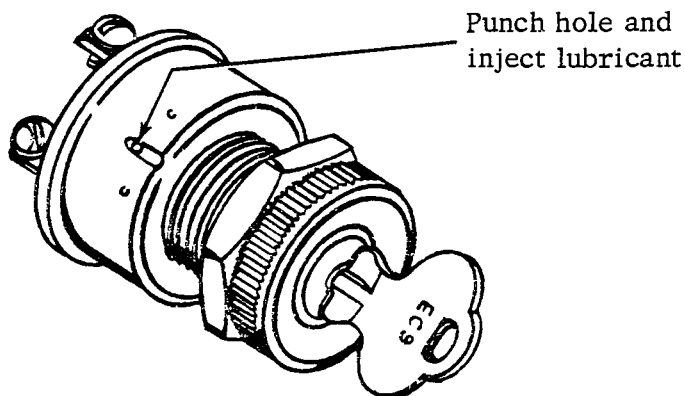
Due to a production oversight on 1974 models, lubricant was omitted on the ignition key switch indexing plate, which could cause the switch to bind.

The lubricant can be injected into the switch after removing the switch from the vehicle and punching a small hole in the notched area as shown below.

To remedy or prevent a binding problem, lubrication with a silicone lubricant is recommended.

If this lubrication injection doesn't remedy the binding, inject lubricant into the 1/8" tumbler lubrication hole located in the mounting nut thread area.

Continued binding indicates switch is defective and should be replaced using Part No. 71500-59A.
