No. 679

December 17, 1974

## HIGH VOLTAGE CORRECTION / X-90

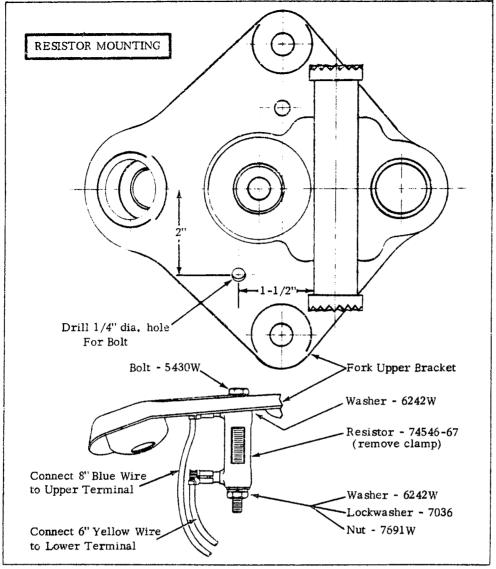
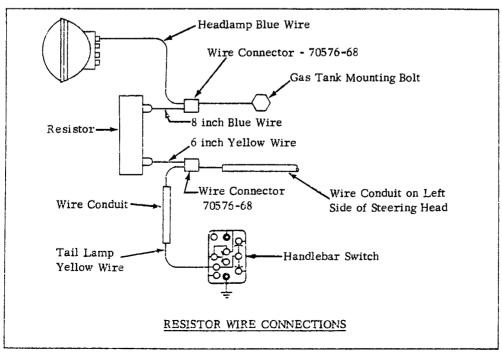
Premature light bulb failure on the X-90 can be caused by excessive voltage. This condition may be the result of insufficient grounding of the electrical system. If this problem exists, the following tests should be made to determine cause.

- 3. Engine: The engine is rubber mounted, therefore, it is advisable to add a ground wire from the lower right rear engine mount to the rear mounting screw of the rear brake stoplight switch. (Note install the wire between the frame and lock-washer after the contact area has been cleaned of paint). Again, take a voltage reading as stated previously. If the reading is at 8 volts, or above, a resistor should be installed to reduce voltage as shown in the following diagrams.
