TRANSMISSION / XL, XLCH-1000

The following items regarding XL/XLCH transmissions are for your attention:

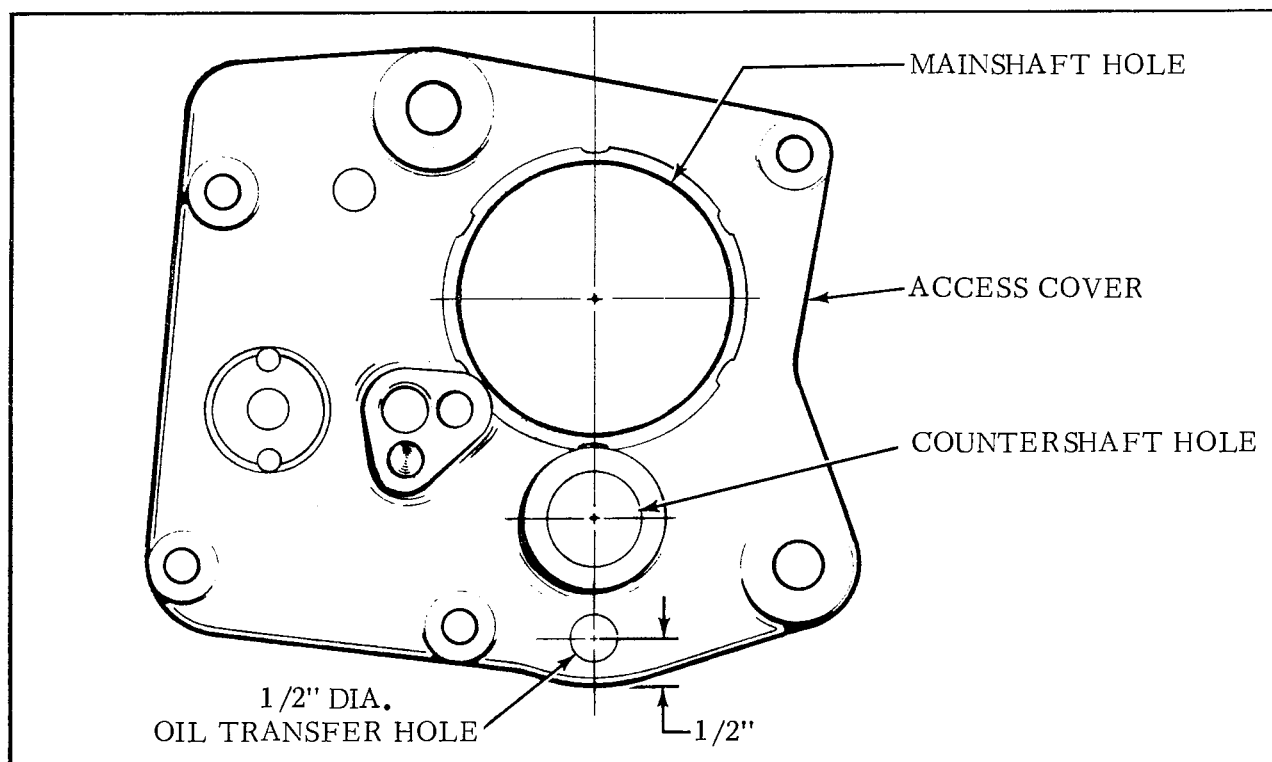
ACCESS COVER OIL HOLE LOCATION

1. We have recently received several reports of Model XL/XLCH transmissions with a blocked oil transfer hole in the access cover between the chain compartment and the transmission gear box, resulting in little or no oil supply to the transmission. We recommend that the transmission drain plug be removed during setup of all 1975 XL/XLCH engines which were received before March 1, 1975, and if less than 1.5 pints of oil runs out, the access cover should be checked to see if the oil transfer hole is open. If you find that the hole is blocked, it can be opened by tapping the casting with a hammer and punch at the hole location as shown in the illustration. This should be done carefully to prevent chips from entering transmission. Loose chips should be removed from hole, or flushed out the transmission drain hole.
