CLUTCH PUSH ROD BEARING / FL, FLH, FX, FXE

Service Letter

May 9, 1975

SERVICE INFORMATION

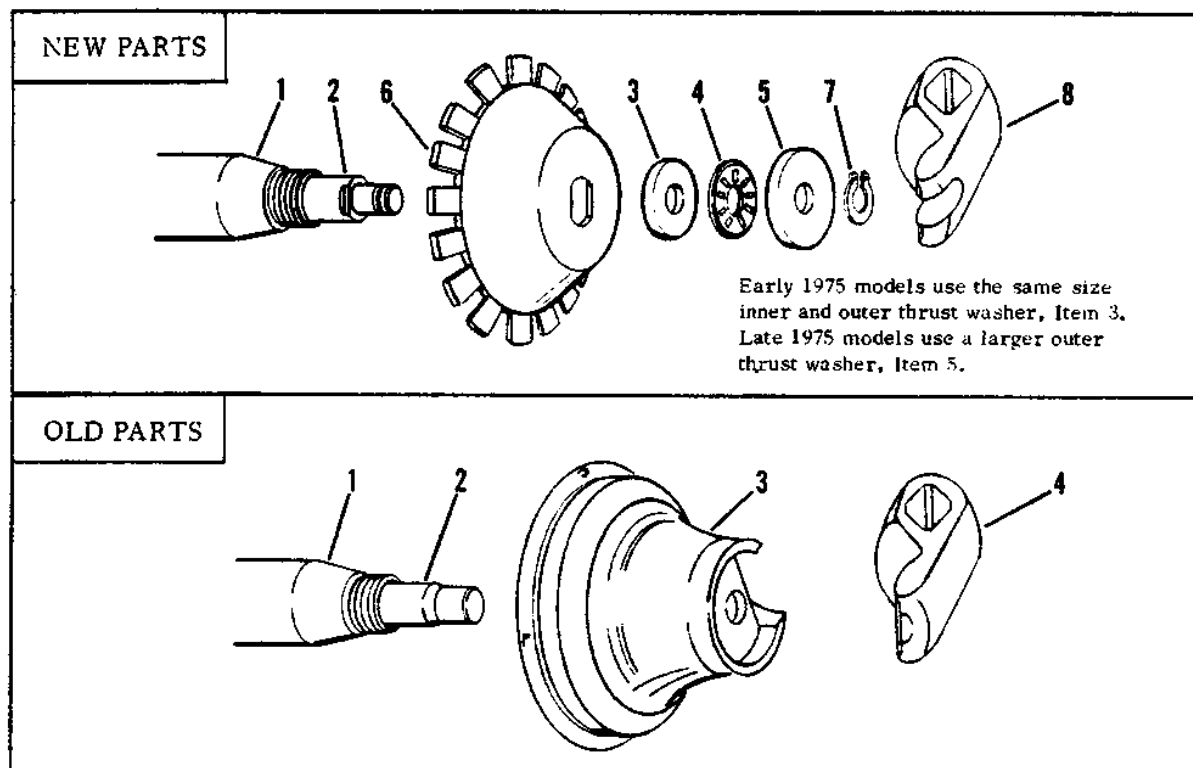
Starting in mid-February 1975, all FL/FLH/FX/FXE models incorporate a new design clutch push rod thrust bearing. The simplified design consists of the following new parts shown in the illustration and list. Related replaced parts are also shown.

With exception of mainshaft, new parts are not interchangeable individually with old parts.

NOTE: When disassembling clutch, it is no longer possible to remove clutch push rod from clutch side of transmission, because it is now retained by a lock ring. Therefore, it is necessary to use recommended puller 95960-41A to remove clutch hub to protect the clutch push rod end from damage.
