REAR BRAKE PEDAL LEVER / 1975 SS-250

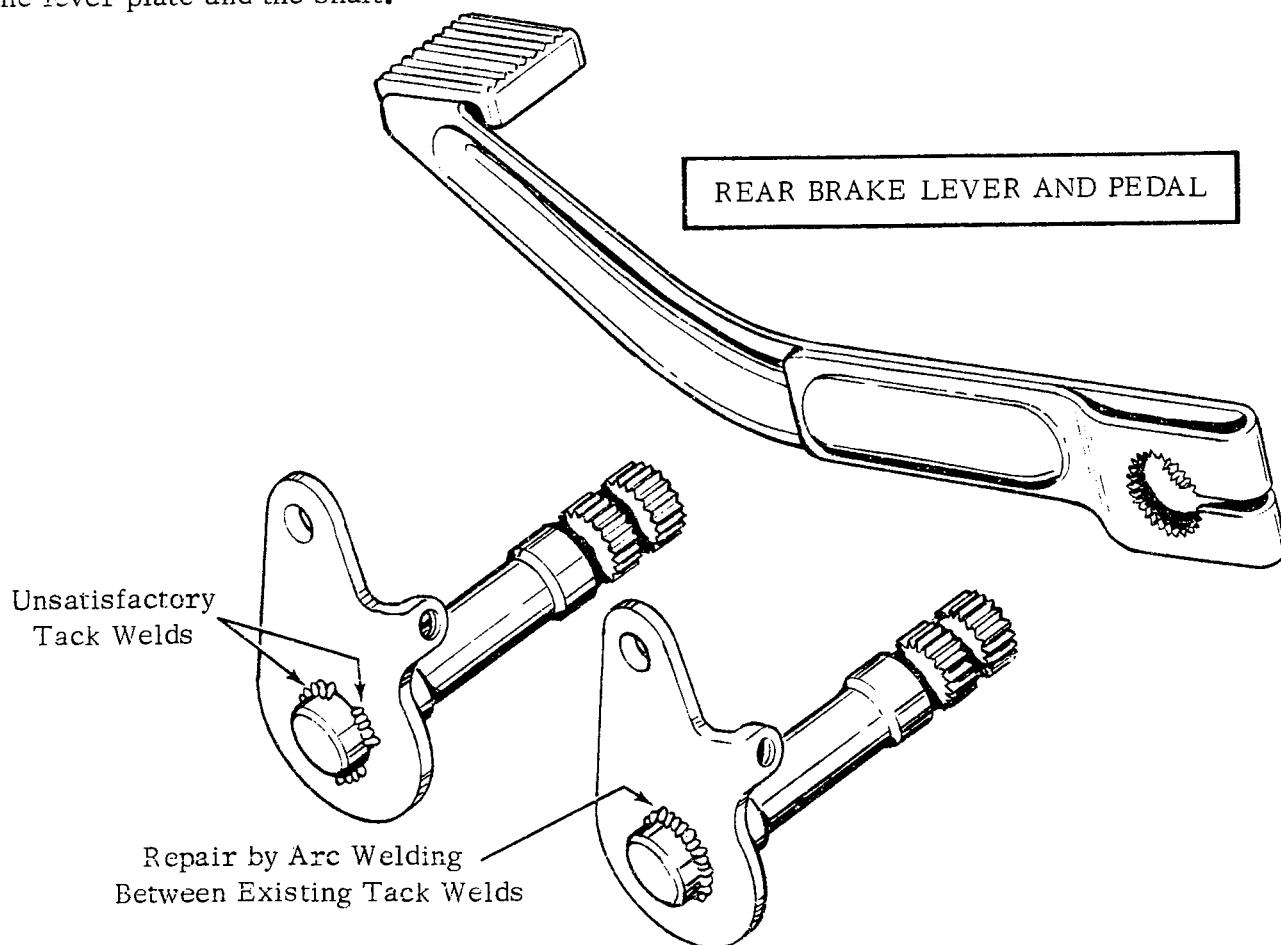
All Harley-Davidson dealers were notified by Service Letter dated May 2, 1975, that some early 1975 SS-250 motorcycles incorporate faulty welds in the rear brake pedal lever. The rear brake pedal pivot shaft to which the rear brake lever plate is welded, and which actuates the rear brake cable, may have improper weld penetration at the three fillet welds. Failure of the welds would make the rear brake inoperative, possibly causing an accident with personal injury.

Make three satisfactory new welds between existing three welds as shown in the illustration. Use arc welding equipment or oxy-acetylene equipment with welding rod, suitable for welding low carbon steel to produce good weld penetration between the lever plate and the shaft.
