## OIL PUMP / 1977 XL, XLCH, XLT, XLCR

The information in this bulletin should be used in conjunction with previous Service Bulletin No. 708 - Breather Valve

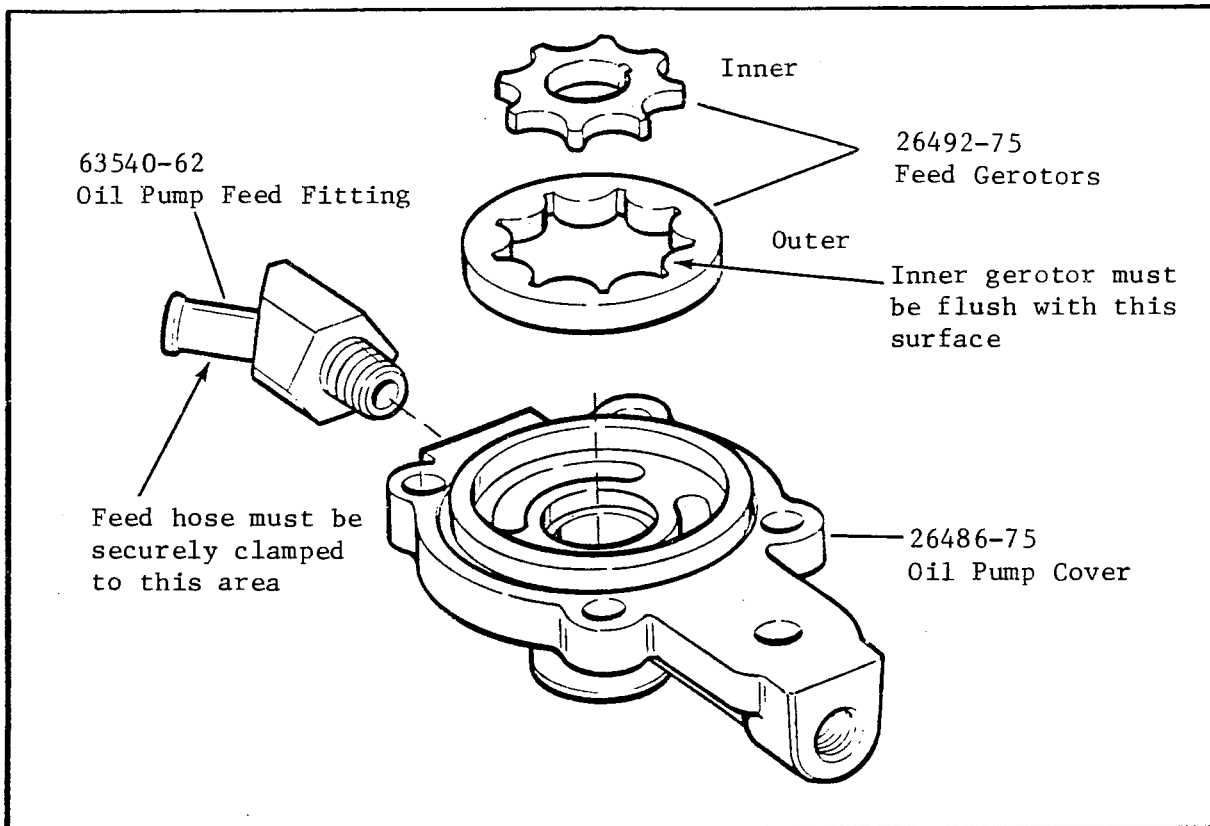
Oil Pump Cover, Feed Gerotors and Feed Hose Fitting

Another possible cause of low oil pressure is air leakage into the pump due to a loose hose clamp at the oil pump feed hose fitting, part No. 63540-62, and at the oil tank feed hose fitting. If the existing feed hose clamp, part No. 10020, cannot be evenly and securely crimped to the fittings, remove the clamp and install a worm drive hose clamp. This will prevent air leakage into the system which could cause loss of oil pressure due to an airlocked pump.

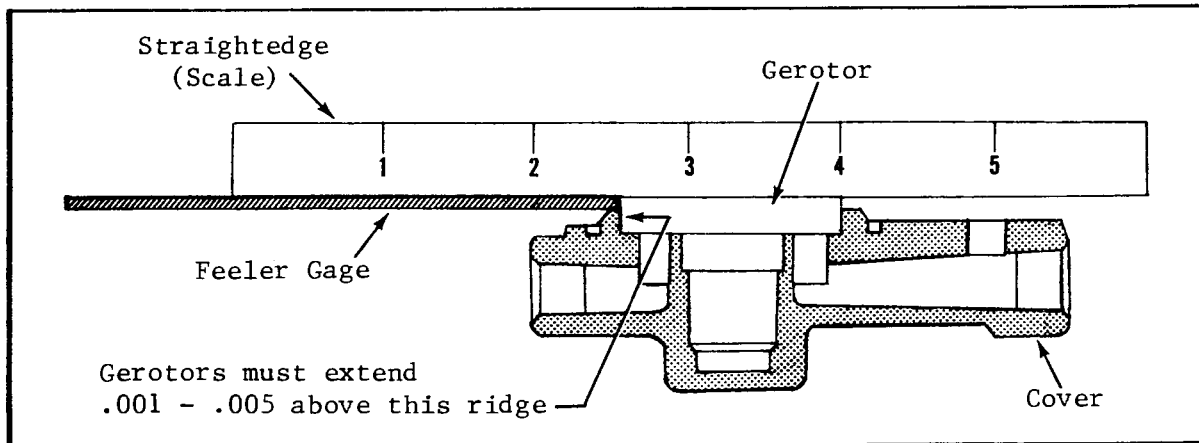
Method of Gerotor Measurement

Zero gerotor (gear) side clearance must be maintained by the flat spring located between the upper and lower gerotor sets in the oil pump in order to provide adequate oil pressure. For the spring to function properly, the upper face of the lower feed gerotors must extend above the cover a slight amount to prevent any side clearance which would allow oil slippage past the gerotors and reduce oil pressure.

The feed (thin) gerotors, part No. 26492-75, are located within the oil pump cover, part No. 26486-75, and should extend .001" - .005" above the cover's aluminum ridge which surrounds them as measured with a feeler gage (See Illustration). The later gerotors extend up to .011" above the ridge. If the feed gerotors do not extend above the ridge within the specified range, remove them, invert cover on flat surface upon a piece of sandpaper (#280 grit to start - #400 grit to finish) and sand cover ridge evenly until the gerotors extend properly when inserted. Then, using a micrometer, check to see that both the inner and outer gerotors are the same width (thickness). If the widths measure equally but the gerotors are not equal in height when placed into the cover, the cover surface is not flat and the cover should be replaced. Be sure to check the gerotors in the new cover using a straight-edge to assure a level surface and the proper elevation above the ridge.

Oil pump covers found with an uneven gerotor surface should be removed. Submit a properly completed warranty form following normal warranty procedures. Use job code base number 3341 for .8 hour labor credit.
