SHOWA REAR SHOCK ABSORBERS / XL-1000

HARLEY-DAVIDSON MOTOR CO., INC.

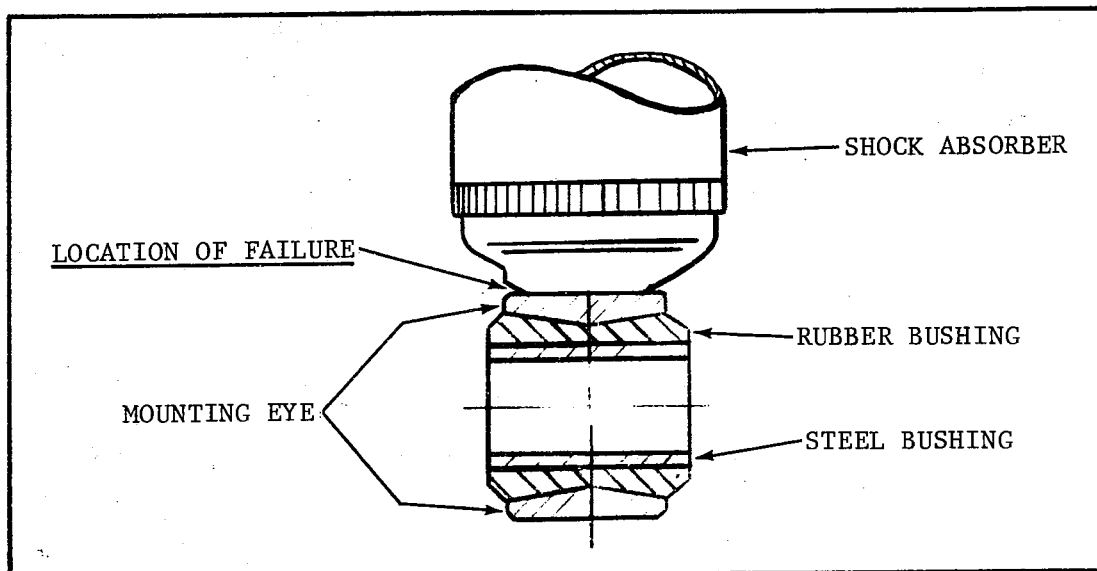
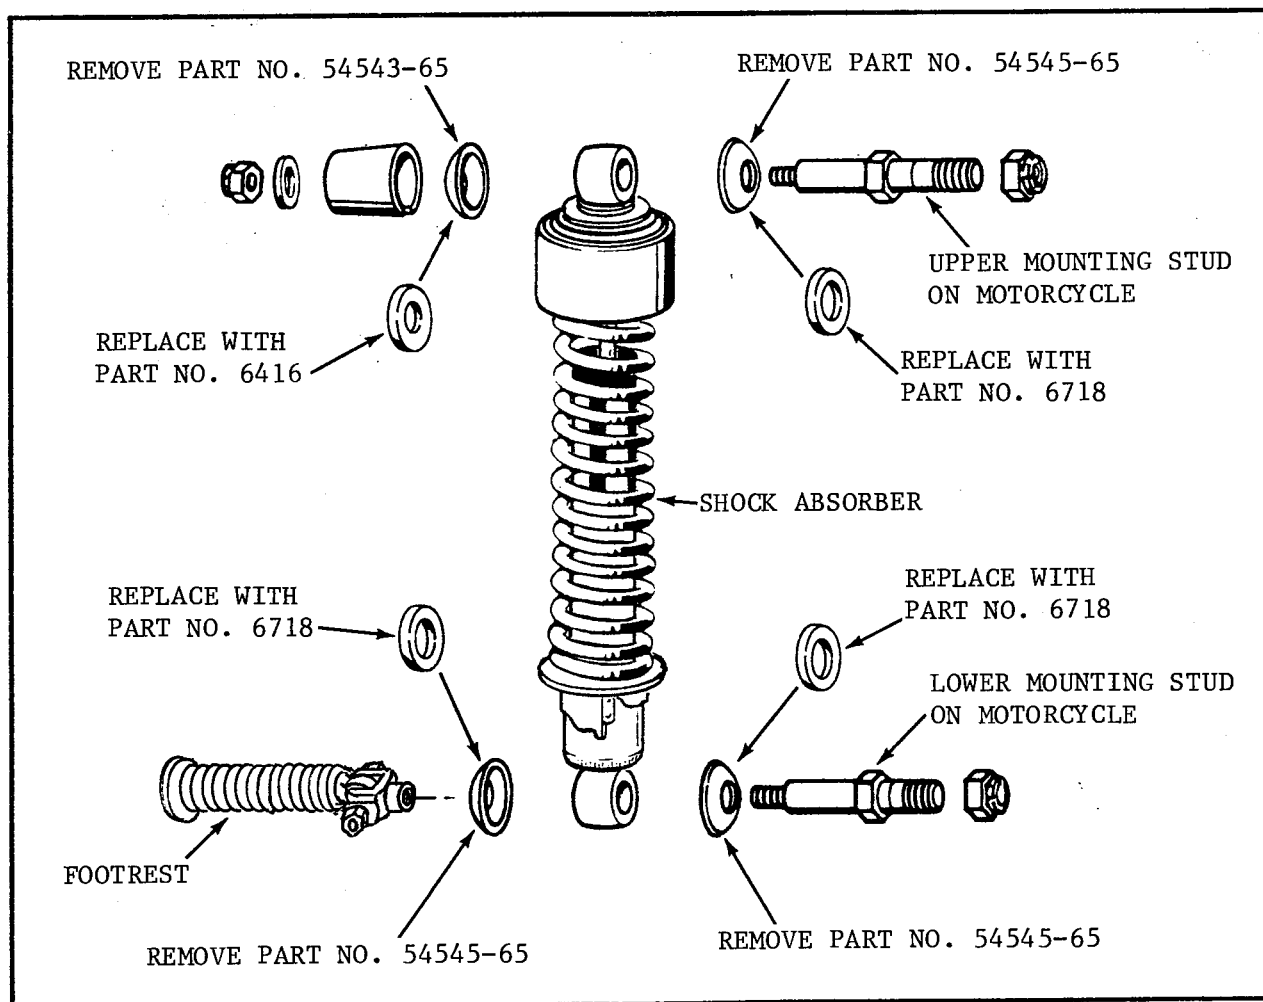
REAR SHOCK ABSORBER MOUNTING

The shock absorbers of motorcycles involved in this safety defect are assembled with 3 cupped washers, part No. 54545-65 and 1 cupped washer, part No. 54543-65 instead of 3 flat washers, part No. 6718 and 1 flat washer part No. 6416.

Installation of incorrect cupped washers prevents either the upper or lower shock absorber eyes from pivoting freely when the suspension system moves, causing stress on the shock absorber eye leading to failure at low mileage. Failure of upper or lower mounting eye of both shock absorbers will cause the suspension to collapse and lock the wheel with possible loss of control of the vehicle, and an accident. Failure of the upper or lower mounting eye of only one shock absorber will not cause suspension collapse, but can affect handling detrimentally with possible loss of control and an accident.

Incorrect cupped washers are shown assembled and should not be used. Correct flat washers shown should be used instead of cupped washers.

We direct you to immediately contact the owners of these motorcycles and inform them that they must not be used until new shocks are installed with correct flat washers. This also applies to unsold motorcycles in your possession. If shock absorbers have not been assembled but are only in your parts stock, they must be used with correct flat washers part No. 6718 (3) and part No. 6416 (1) per shock absorber (See Illustration).

Do not reuse any shock absorbers which have been previously installed with cupped washers. Such shock absorbers could have incurred damage which is not apparent by visual inspection.
