REAR BRAKE CONTROL LINKAGE / 1979 XLH-1000

HARLEY-DAVIDSON MOTOR CO., INC.

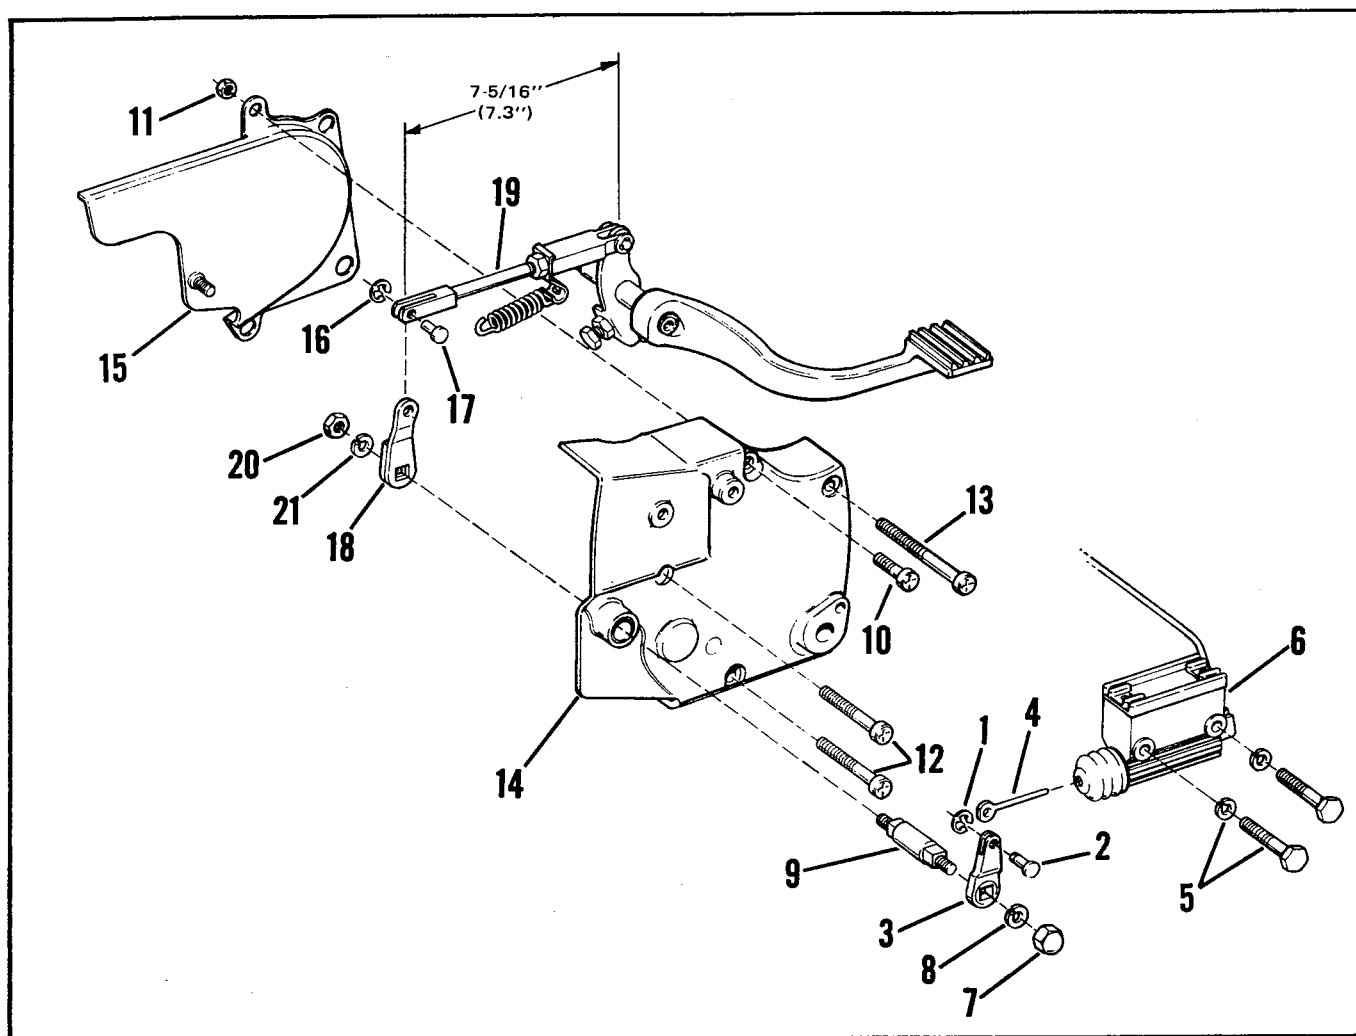
REAR BRAKE LINKAGE

The problem involves distortion of the brake linkage inner pivot arm at the pivot shaft hole when a high brake pedal force is applied. The distortion of the square hole in the pivot arm and mating square on the pivot shaft increases the brake linkage free play and results in excessive brake pedal travel and a lowered pedal position. The lowered pedal position decreases the operator's ability to effectively apply the rear brake.

1. Disconnect master cylinder plunger rod (4) by removing retainer (1) from clevis pin (2) and removing pin from outer pivot arm (3).
2. Remove two master cylinder mounting bolts and lockwashers (5). Position master cylinder (6) out of way (do not disconnect hydraulic brake line).
3. Remove outer arm (3) from shaft (9) by removing an acorn nut (7), lock washer (8).
4. Loosen sprocket cover (14) by removing mounting screw (10) and nut (11), two screws (12) and long screw (13).

5. Remove right footrest.
6. Loosen right rear muffler support.
7. Carefully pry exhaust system out to clear for sprocket cover removal. Remove outer sprocket cover (14).
8. Remove retainer (16) from brake rod inner clevis pin (17) and remove clevis pin from inner lever arm (18) to disconnect brake rod (19).
9. Remove shaft with inner lever from cover.
10. Disassemble inner pivot arm (18) from shaft (9) by removing inner nut (20) and lock washer (21).
11. Reassemble in reverse order using new inner pivot arm (18), pivot shaft (9) 1/2" hex acorn nut (7) and 5/16 in. lock washer (8).

NOTE: The new pivot shaft will fit one way only. The shaft square end with rounded corners fits new inner pivot arm only.

12. After installing inner lever and shaft on brake rod clevis and before installing covers, check brake rod clevis center distance (7-5/16 in. dimension) shown in illustration. Adjust clevis on rod threads as necessary to obtain correct center distance.
13. After completely assembled, check for proper master cylinder plunger rod free play and adjust brake pedal stop bolt if necessary, to obtain 1/16 in. free play before plunger contacts piston in master cylinder. See Owner's Manual for procedure.
14. Check brake for correct operation.
