PRIMARY CHAIN TENSIONER / 1200; 1340 MODELS

HARLEY-DAVIDSON MOTOR CO., INC.

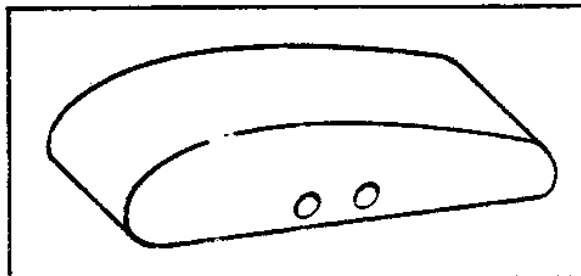
The material used for the primary chain tensioner has recently been changed from a black color polyethylene to a white color Zytel material for improved durability and resistance to wear at high temperatures. Some accelerated tensioner wear has been reported under severe operating conditions at high air temperatures. This condition has not been experienced under normal operating conditions.

These recommendations are being made to prevent possible engine/oil contamination from the worn tensioner particles. Accumulation of these particles in the oil filter and oil screen will be evident during an oil change. Eventually tappet lifter noise or primary oil return line blockage may occur.

To prevent any possibility of a problem in motorcycles in service we request that you replace all existing black tensioners in customers' motorcycles at no charge. We also request that you replace all tensioners of affected motorcycles in your store and in your parts inventory as soon as possible.

As your servicing plan, we urge that you replace all tensioners in the affected motorcycle VIN range during the normal course of regular service or when contamination symptoms become evident.
