April 3, 1979

TRANSMISSION CHANGES / 1979 1000 CC MODELS

HARLEY-DAVIDSON MOTOR CO., INC.

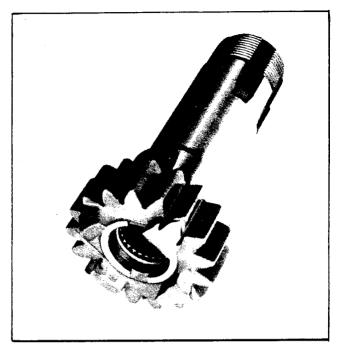
The following changes were made in early 1979 production engines to improve the engagement of the clutch teeth between the mainshaft 2nd gear and the clutch gear.

On September 21, 1978 starting crank-case No. 779-264-021, the mainshaft clutch gear thrust washer thickness was decreased .020 in. from .232 in. (nominal) to .212 in. (nominal). New thrust washer, part No. 35216-79, replaced old part No. 35361-56. Clutch gear assembly with new washer, part No. 37448-79 replaced old clutch gear assembly, part No. 37448-71.

At the same time, the transmission drive sprocket hub width was increased .020 in. to compensate for the clutch gear change. New drive sprocket, part No. 35205-79 replaced old part No. 35205-52A.

The new drive sprocket must be used in conjunction with the clutch gear having the thinner thrust washer to correctly position the drive sprocket.

Either install a new washer part No. 35216-79, in the old clutch gear part No. 37448-71, or use a new clutch gear, part No. 37448-79, which comes with the new washer already installed.

To convert an old clutch gear, remove the thrust washer and needle bearing using puller, part No. 95760-69 with the 3/4 inch collet, pressing out with a rod inserted from the opposite end of gear. If the tool is not available, parts can also be drifted out using a hammer and punch, but this may damage the bushing and necessitate bushing replacement.

Press in new needle bearing, part No. 35961-52 and new thrust washer, part No. 35216-79. When pressing in needle bearing, press on printed side of bearing cage. Outer face of bearing cage should be flush with washer seating face--do not bottom the bearing in the hole when pressing in.

After assembling sprocket on mainshaft, be sure to check for the specified .003 to .009 in. mainshaft end play with preload. Adjust if necessary using variable thickness mainshaft thrust washer according to the procedure in Service Manual, part No. 99484-79.
