## PUSH ROD COVERS — 1200/1340 cc ENGINES

HARLEY-DAVIDSON MOTOR CO., INC.

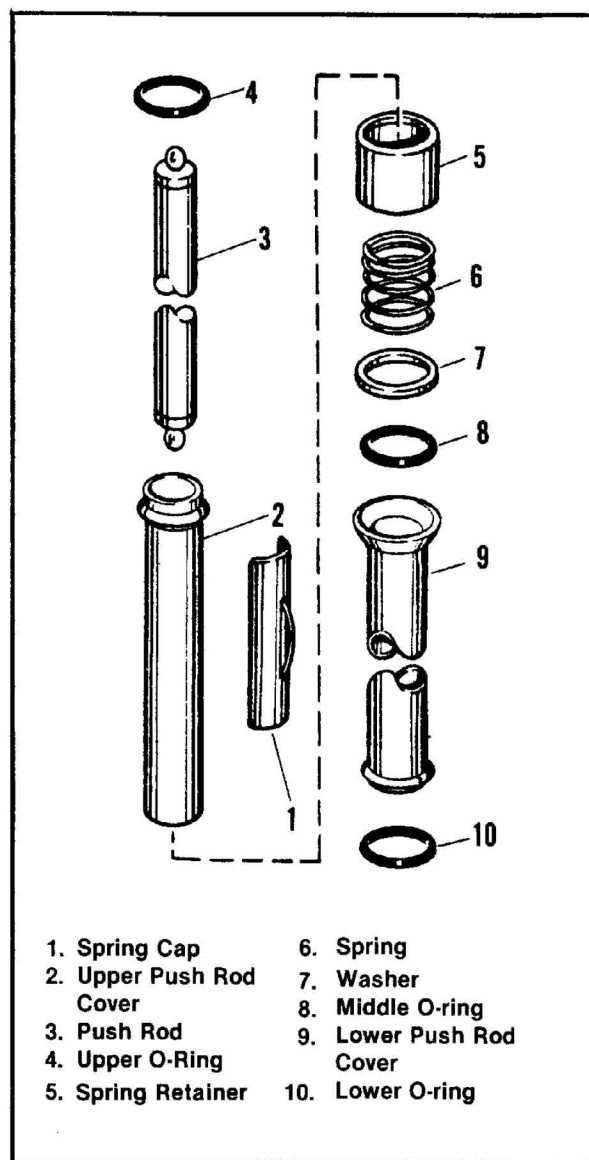
Figure 1. Push Rod Assembly

These engines used new style push rod covers and O-rings. The front cylinder exhaust push rod cover is too short and may cause the leak. To prevent this from occurring, replace this exhaust push rod cover with a lengthened push rod cover, part number 17935-79A. Use the following procedure.

1. See Figure 1. Remove the spring cap (1) on the front cylinder exhaust push rod. Lift up the lower push rod cover (9) to expose the adjusting screw.
2. See Figure 2. Loosen the locknut (1) and bottom the adjusting screw (2). Remove the push rod assembly (3).
3. See Figure 1. Remove the upper push rod cover (2) from the push rod assembly.
4. Place a lengthened push rod cover, part number 17935-79A over the push rod and assemble items 2-10 as shown in Figure 1.
5. See Figure 2. With the tappet in its lowest position, turn the adjusting screw (2) upward, shortening the push rod, until push rod has a noticeable shake. Place a wrench on the flats at the base of the push rod to prevent it from turning. Slowly turn adjusting screw downward until all shake has been eliminated. Turn the adjusting

6. Install the spring cap (1, Figure 1).

If the new lengthened push rod cover is not readily available, old style push rod cover, part number 17935-66 may be used instead, providing a cork gasket, part number 17955-36 is substituted for the upper O-ring (4, Figure 1).
