## REAR BRAKE MASTER CYLINDER PUSH ROD / XLCR-1000

HARLEY-DAVIDSON MOTOR CO., INC.

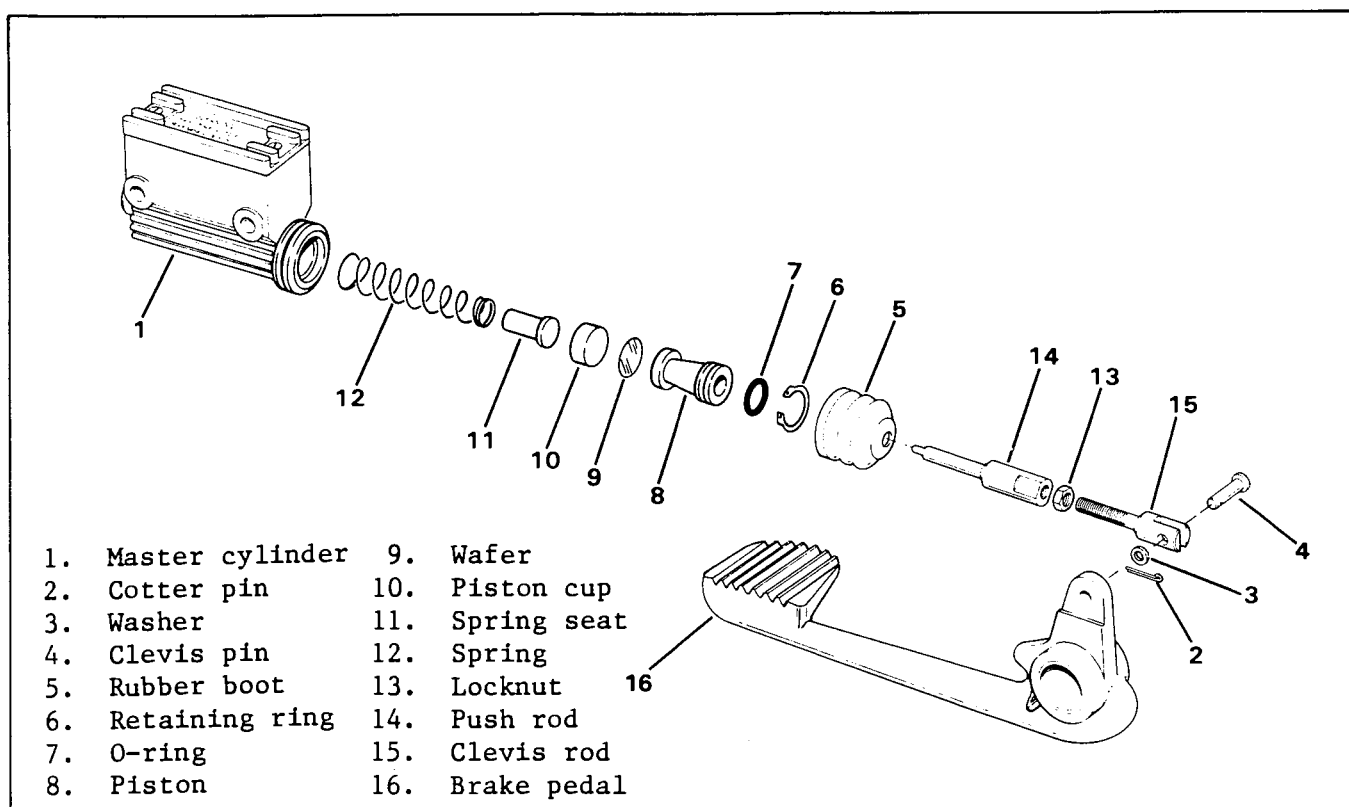
Rear Brake Master Cylinder - Exploded View

All XLCR-1000 motorcycles produced during the 1977 and 1978 model season were shipped with rear brake master cylinder push rods having insufficient contact area with the rear brake master cylinder plastic piston. In this condition it is possible that during extremely high brake pedal effort such as during an emergency stop, the brake rod could penetrate the master cylinder plastic piston, with possible loss of hydraulic pressure.

The master cylinder (1) is mounted to the rear chain sprocket cover, just above the rear brake pedal. Disassemble as follows. Remove master cylinder cover and gasket.

Disconnect brake linkage by removing cotter pin (2), washer (3) and clevis

pin (4). Pull linkage assembly out of master cylinder. Remove the following: rubber boot (5), retaining ring (6), O-ring (7), piston (8) wafer (9), piston cup (10), spring seat (11) and spring (12).

Dip all internal parts from supplied piston kit in DOT 5 type brake fluid prior to assembly. Insert these new parts from kit into master cylinder in order shown in illustration. Make sure O-ring is positioned in groove of piston before inserting piston into cylinder.

Loosen jamnut (13) and unscrew old push rod (14) from clevis rod (15). Install new push rod, part No. 42312-80 supplied to you, on clevis rod. Do not tighten jamnut until brake linkage is properly adjusted later.

Work brake pedal lever up and down by hand to determine free play before push rod contacts piston in master cylinder. Free play of push rod should be approximately 1/8 inch to be sure that master cylinder pressure is relieved. To adjust free play, push rod on clevis rod threads - forward to decrease free play or rearward to increase free play. Adjustment should be made starting with linkage very loose, then adjusting push rod until 1/8 inch free play in the push rod is obtained. Tighten locknut (13).
