## AF HARLEY-DAVIDSON SERVICE BULLETIN

No. M-754

SAFETY DEFECT CODE 044

### **REAR BRAKE MASTER CYLINDER PISTON / 1979 MODELS**

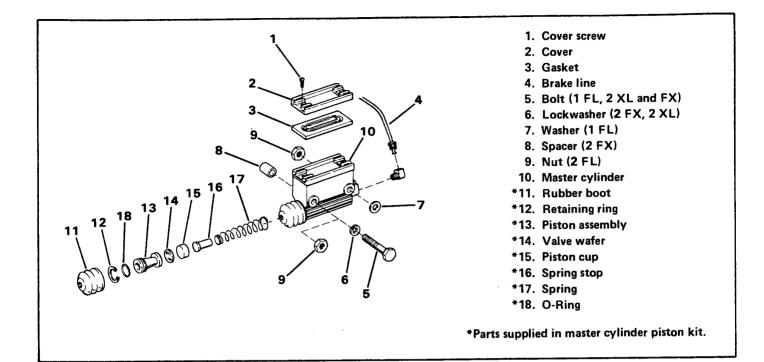
A quantity of 1979 model 1200/1340 and 1000cc motorcycles were assembled and shipped with master cylinder pistons made from an incorrect material as received from our supplier.

The incorrect material may allow water absorption to a greater degree than the correct material specified by Harley-Davidson. A plastic piston made of this material, in incorrect isolated instances, might stick in the master cylinder piston bore. This condition would most likely come on gradually as the piston absorbs moisture and swells. If this sticking occurs, the brake may not fully release and will have a tendency to drag. If the motorcycle operator does not heed this prior warning, it is possible, though extremely unlikely, that this condition may become severe enough to make the rear wheel skid, or a dragging brake may generate enough heat to make the brake fluid boil causing an ineffective brake. Either of these conditions could cause the motorcycle operator to lose control.

XL Models: Remove master cylinder cover screw (1), cover (2) and gasket (3). Disconnect brake line (4) at master cylinder. Remove bolts (5), lockwashers (6) and remove master cylinder (10) from motorcycle allowing brake operating linkage to remain connected.

FL Models: Loosen master cylinder mounting bolt (5) and nuts (9) enough to remove chrome cover (not shown). Remove master cylinder cover screw (1) cover (2) and gasket (3). Disconnect brake line (4) at master cylinder. Remove front bolt (5) washer (7) and nut (9), remove rear stud nut (9) and remove master cylinder (10) from motorcycle.

FX Models: Remove exhaust pipes and muffler. Remove master cylinder cover screw (1) cover (2) and gasket (3). Disconnect brake line (4) at master cylinder. Remove bolts (5) lockwashers (6) and spacers (8), and remove master cylinder (10) and sidecover (not shown) from motorcycle.

All Models: Remove rubber boot (11), retaining ring (12), piston assembly (13), wafer (14), piston cup (15), spring stop (16) and spring (17).

Reassemble master cylinder using new parts from kit (marked with asterisk \* in illustration). Dip all parts in new DOT 5 brake fluid and assemble in order shown with 0-ring installed in groove on piston.
