VALVE CAM TIMING

A small quantity of early 1980 Sportster engines were produced with incorrect front exhaust cam gear timing. Most of the suspect engines occur within the range of crankcase identification numbers 780-213-041 to 780-211-001, although some earlier engines are also affected. The valve timing was corrected on most engines, within the above range, before leaving the factory, and such engines were identified with an orange dot on the gear case cover generator boss.

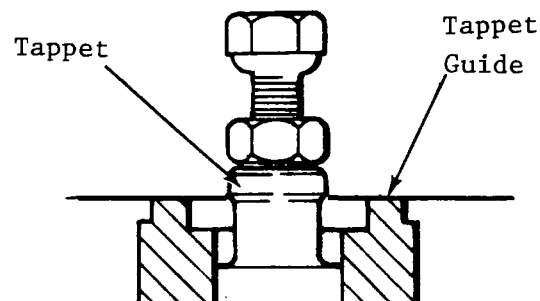
CAM TIMING CORRECT

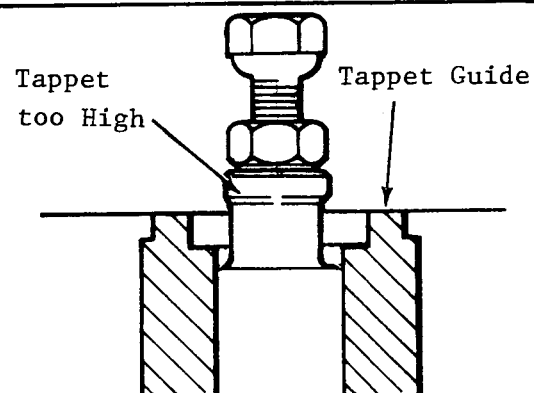
CAM TIMING INCORRECT

Remove gear case cover.
Remove F.E. cam gear and reinstall
one tooth counterclockwise

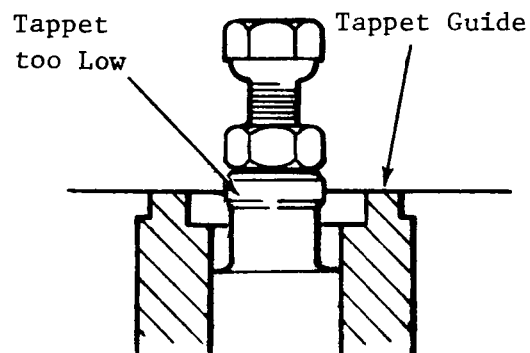
CAM TIMING INCORRECT

Remove gear case cover.
Remove F.E. cam gear and
reinstall one tooth clockwise
