BATTERY POSITION/1980 XLH, XLS

HARLEY-DAVIDSON MOTOR CO., INC.

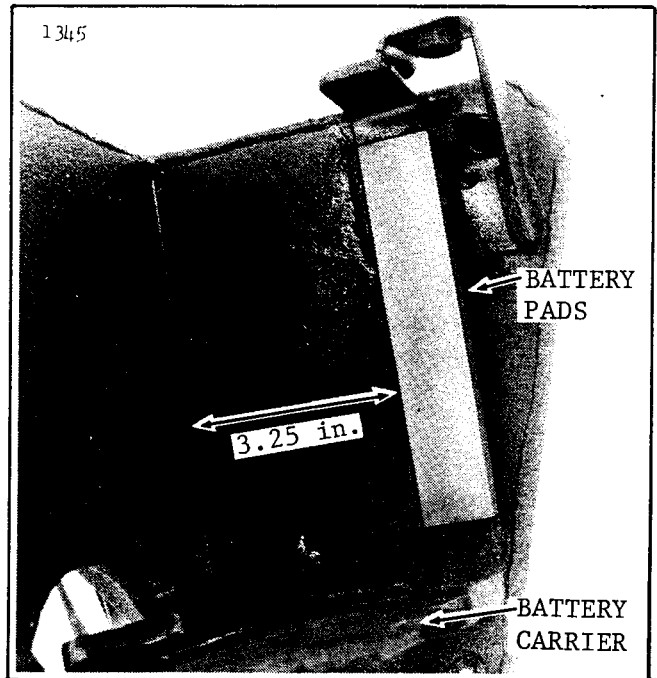
ILLUSTRATION 1
BATTERY CARRIER WITH PADS INSTALLED

The batteries of some 1980 XLH, XLS motorcycles have been mispositioned within the battery carrier. The pad the battery rests on is thick enough to allow the battery to be pushed over the carrier retaining edge until the battery vent fitting is flush against the oil tank. In this position, the vent fitting could break.

This condition should be corrected as follows. Remove the seat to expose the battery and carrier and then remove the battery. Take two (2) battery cover pads, Part No. 66352-65, which have adhesive backing on one side, and glue them together. Then attach pads to the oil tank in front of the vent fitting position in the carrier. (Approximately 3.25 inches from inside wall.) (See Illustration 1.) This will effectively space the battery away from the oil tank.
