INNER PRIMARY CHAIN HOUSING/1200 AND 1340 CC MOTORCYCLES

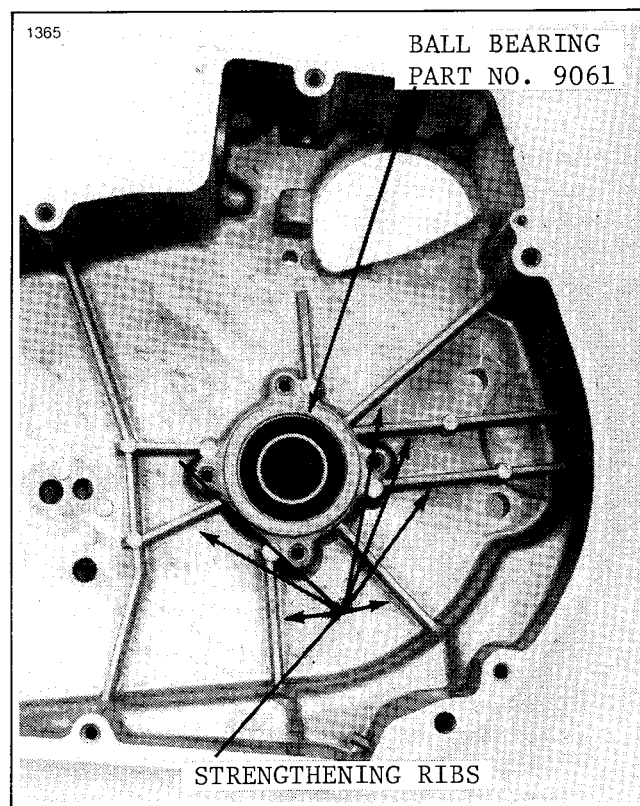
FIGURE 1. INNER PRIMARY CHAIN HOUSING

The chain housing ball bearing, Part No. 9061, located within the inner primary chain housing has exhibited shortened life in some 1200 and 1340cc motorcycles. The bearing wears at an accelerated rate and must be replaced at frequent intervals. This can be caused by a slight misalignment of the transmission shaft within the housing. This causes excessive sideloading and the walls of the housing can flex with the shaft and accelerate bearing wear.

Whenever you encounter a motorcycle with recurring chain housing bearing failure, check for proper alignment of the transmission shaft and inspect the inner primary chain housing for evidence of this condition. Look for cracks around the bearing and inner walls of the housing. If such cracks are evident, replace the entire inner housing.

An improved, strengthened inner primary chain housing has been put into production that should minimize this occurrence along with improved transmission shaft alignment techniques at York. The inner wall of the housing has been strengthened with ribs which increase the stiffness of the wall and greatly reduce flexing of the housing. (See Figure 1.) These improved housings were put into production above V.I.N. number 25186 J0 on all 1200 and 1340cc models, and all Parts and Accessories stock contains the improved design. (See Paragraph 13 for affected part numbers and models.)
