SAFETY DEFECT CODE 047

March 7, 1980

SPROCKET MOUNTING SCREWS/1980 FLT

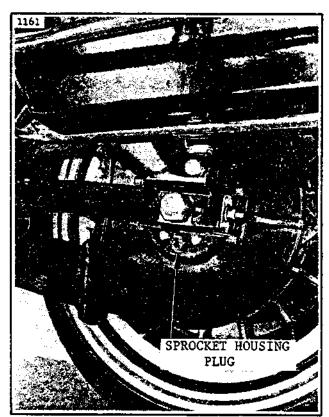
Figure 1. Plug on Sprocket Housing

The rear wheel sprocket mounting screws on 62 1980 FLT model motorcycles may be affected by hydrogen embrittlement. This condition might cause the head of an embrittled screw to break off and possibly wedge between the aluminum housing and the sprocket. Should this occur, the rear wheel may lockup at low speeds, unless the problem is detected and corrected.

- 1. Place motorcycle on a center stand with the rear wheel raised off the ground.
- 2. Remove the left muffler.
- Remove the plug on the sprocket housing. (See Figure 1.)
