IGNITION SWITCH / FORK LOCK ASSEMBLY / 1980 FLT MOTORCYCLES

HARLEY-DAVIDSON MOTOR CO., INC.

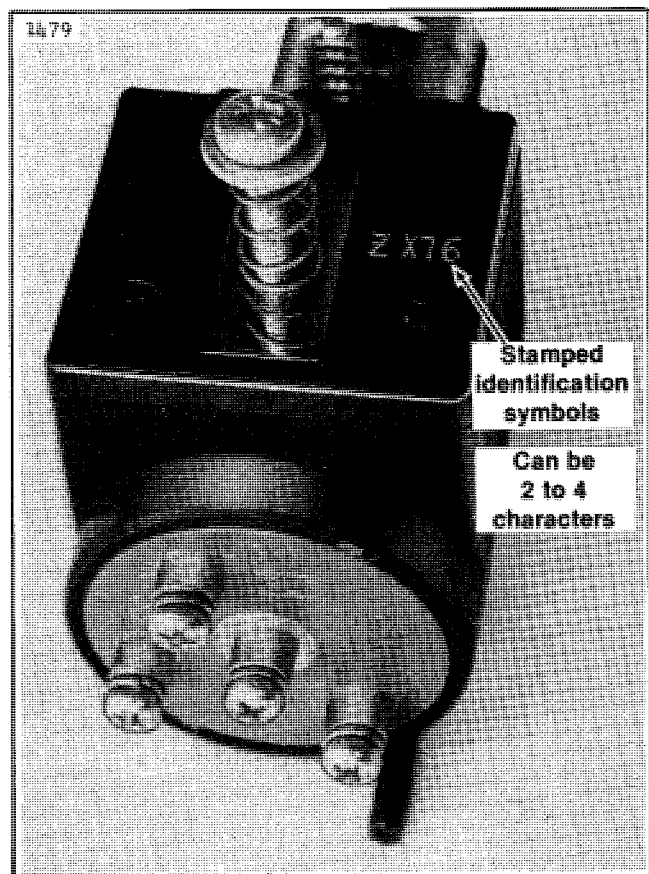
Figure 2. Ignition Switch/Fork Lock Assembly

3. Remove locknuts that secure lower handlebar clamps. These are located under the instrument housing. Be very careful not to scratch the paint on the gas tank while removing.
4. With the locknuts removed, lift the handlebar assembly up and out.
5. Remove the ignition switch tamper shield. Remove the ignition switch knob by pulling on the ignition switch pin located underneath lip of the instrument support housing with needle nose pliers. That will release the knob.
6. You should now be able to see the inside switch housing body. Check for the presence of stamped identification symbols (See Figure 2). If there are no identification symbols stamped on the housing, the ignition switch/fork lock housing must be replaced. Proceed to Step 1 of the Replacement Procedure.

7. If the ignition switch housing has the stamped symbols on the body, proceed to Step 9 of the Replacement Procedure.
