SOLENOID COVER/1977 AND LATER XL MODELS

HARLEY-DAVIDSON MOTOR CO., INC.

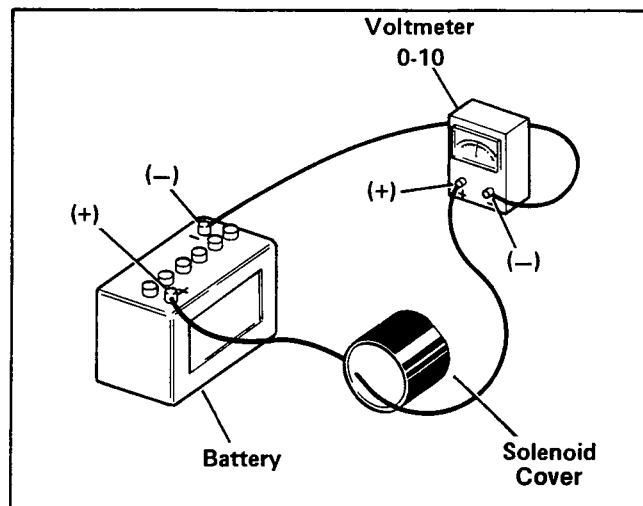
Figure 1. Proper Test Setup

1. Set voltmeter to 10 volt scale.
2. First connect jumper wire to outside solenoid cover and battery positive post. Then connect voltmeter to inside solenoid boot and battery negative post (see Figure 1).

3. If needle reads anything or even flickers while solid contact is maintained, the cover is conductive.
4. If conductive, replace the solenoid cover, Part No. 31457-77. Hold replaced cover for possible inspection.
5. Before installing a new solenoid cover, check the replacement cover using the same procedure.
