## REVISED IGNITION TIMING — 1000 / 1340cc

HARLEY-DAVIDSON MOTOR CO., INC.

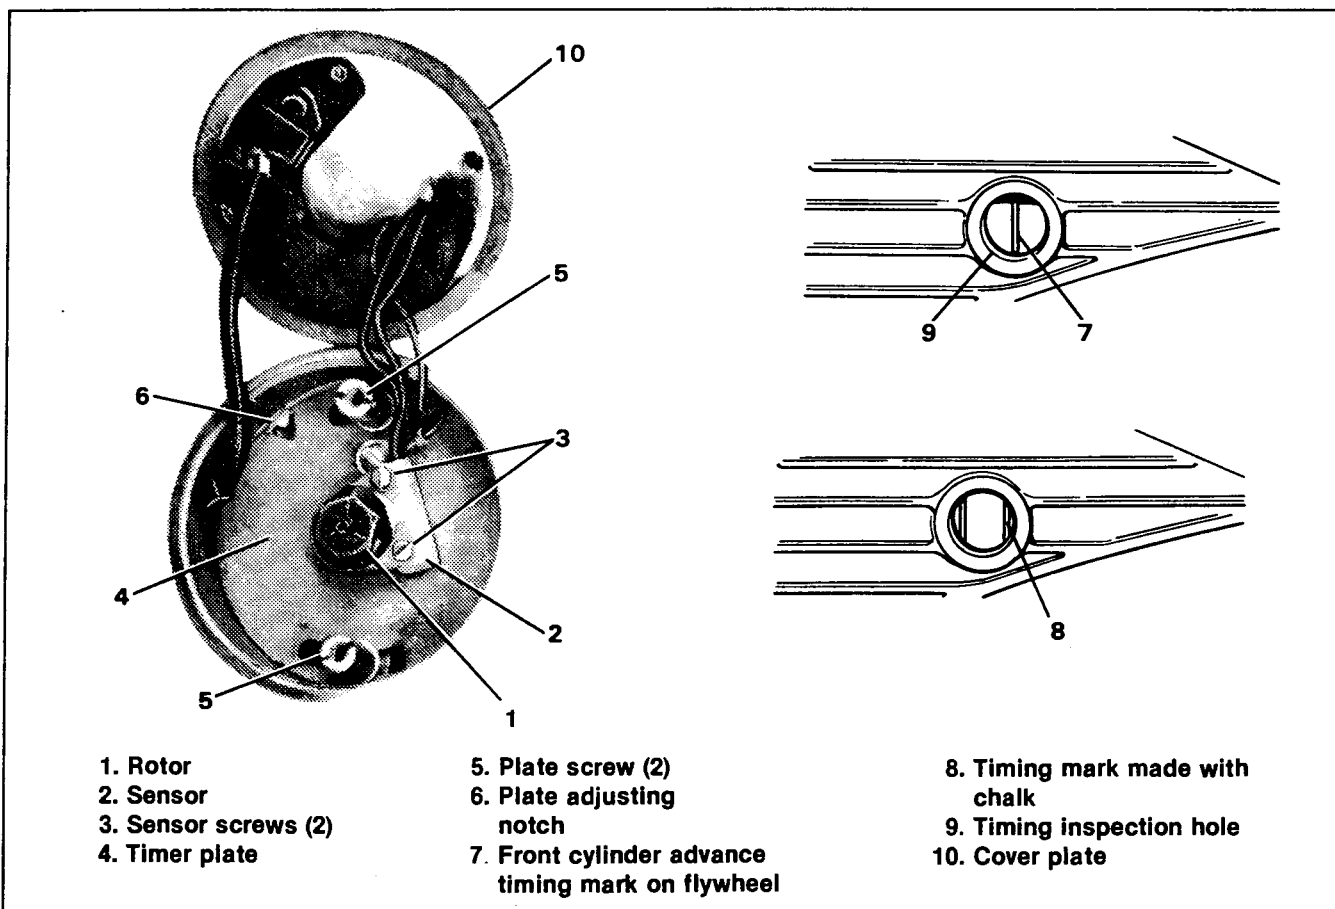
Figure 1. Prestolite Timer and Flywheel Timing Marks

Some owners of 1000cc and 1340cc engines built since January 1, 1978, have experienced a "knocking" and/or "pinging" effect due to the unavailability of fuels with high enough octane ratings.

1. Check the ignition timing as described in the Service Manual under CHECKING ADVANCE TIMING WITH STROBE TIMING LIGHT. Set the timing if necessary.
2. See Figure 1. Turn the engine over until the timing mark (7) is at the extreme front edge of the timing hole (9).
3. Make a new timing mark (8) with a piece of chalk at the extreme rear edge of the timing hole.
4. Start the engine and set the idle speed at 2000 rpm. Retard the timing by shifting the timer plate (4) so the new timing mark (8) moves toward the front of the timing inspection hole. The timing advance should only be reduced in 2½° increments and on-
