SERVICE BULLETIN

M-785 June 10, 1980

SAFETY DEFECT CODE 044 ADDENDUM REAR BRAKE MASTER CYLINDER PISTON / 1979 MODELS

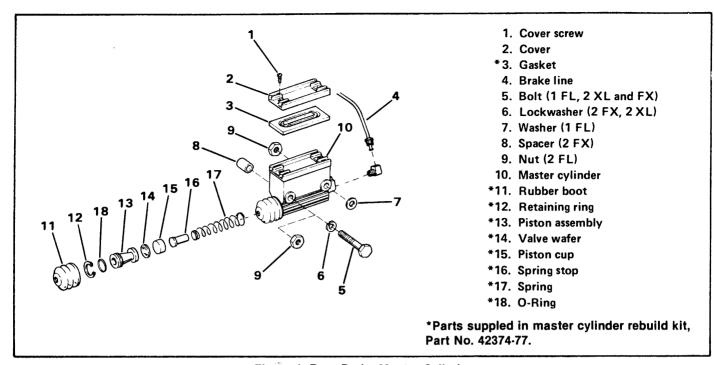
Figure 2. Master Cylinder Pistons

This incorrect material, as outlined in the Safety Defect Code 044 Bulletin No. 754A, may allow water absorption to a greater degree than the material specified by Harley-Davidson. In isolated instances, the incorrect plastic piston could stick in the master cylinder piston bore, a condition which would come on gradually as the piston absorbs moisture and swells. If this sticking occurs, the brake may not fully release and will have a tendency to drag. If the motorcyclist does not heed this prior warning, it is possible, though extremely unlikely, that this condition may become severe enough to make the rear wheel skid, or a dragging brake may generate enough heat to boil the brake fluid resulting in ineffective braking. Either of these conditions could cause the motorcycle operator to lose control.

- Check all parts order stock of master cylinder assembly, Part No. 42415-79.
- 2. See Figure 1. Remove the rubber boot (11) from the master cylinder (10).
- Look inside at the master cylinder piston. The end should be totally black or blue (see Figure 2). If it is not, the master cylinder must be returned for credit with a properly completed Warranty Claim Form.

The parts order assemblies that are found containing the suspect piston MUST be returned to Harley-Davidson Motor Co. with a properly completed Warranty Claim Form. Upon receipt of a properly completed Warranty Claim Form, your account will be credited full parts cost.
