## FORK LOCK ADJUSTING SCREW / 1980 FLT MOTORCYCLES

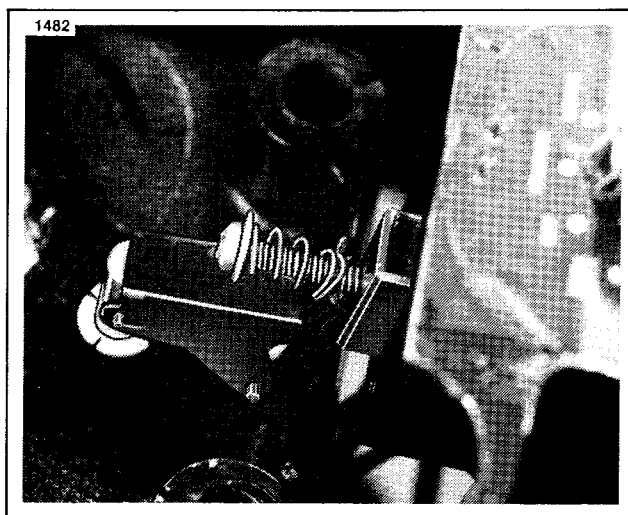
Figure 2. Position of Adjusting Screw Assembly

There is a possibility that the length of the adjusting screw may not provide sufficient thread engagement within the ignition switch/fork lock assembly used on 1980 FLT motorcycles when installed according to specifications. If this screw becomes disengaged, it might allow the fork pin to drop and accidentally engage the fork lock. This possibility can only occur during extreme left hand turns at low speeds when the handlebar itself is physically rotated to its stop and **only** if the adjusting screw becomes disengaged.

3. Remove locknuts that secure lower handlebar clamps. These are located under the instrument housing. Be very careful not to scratch the paint on the gas tank while removing.
4. With the locknuts removed, lift handlebar assembly up and out.
5. Remove the ignition switch tamper shield. Examine switch for Code 048 recall. (See Service Bulletin M-770.) Perform if required.
6. Remove fork lock adjusting screw, spring, and washer (see Figure 2).
7. Reinstall new fork lock adjusting screw and locknut, from 93335 Kit, along with spring and washer from original assembly. Turn it a few turns

into the plunger of the ignition switch assembly (see Figure 3).
