1980 & 1981 FLT SERVICE INFORMATION

TRANSMISSION BREATHER VENT — 1980 ONLY

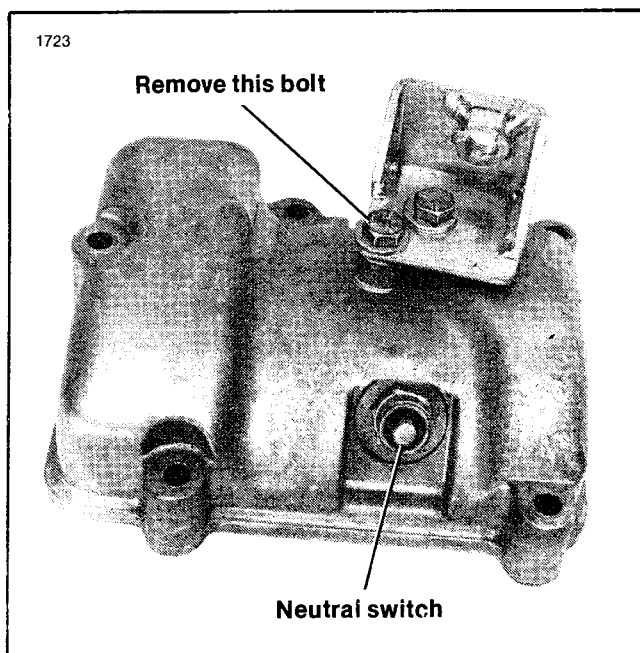
Figure 1. Rear Clutch Cable Bracket Bolt

The 1981 FLT transmissions have been modified to prevent oil leakage at the breather vent. Dealers may wish to make this change on 1980 models if fluid leakage is a problem.

4. See Figure 1. Remove the rearmost clutch cable bracket bolt (1/4-20 x 5/8 in.). See Figure 2. Drill through the bolt head with a 1/16 in. dia. drill. Drill a second 1/16 in. dia. hole lengthwise from the bottom of the bolt to meet the cross hole in the head. Do not drill this hole completely through the head
