## 1981 FXB CHANGES

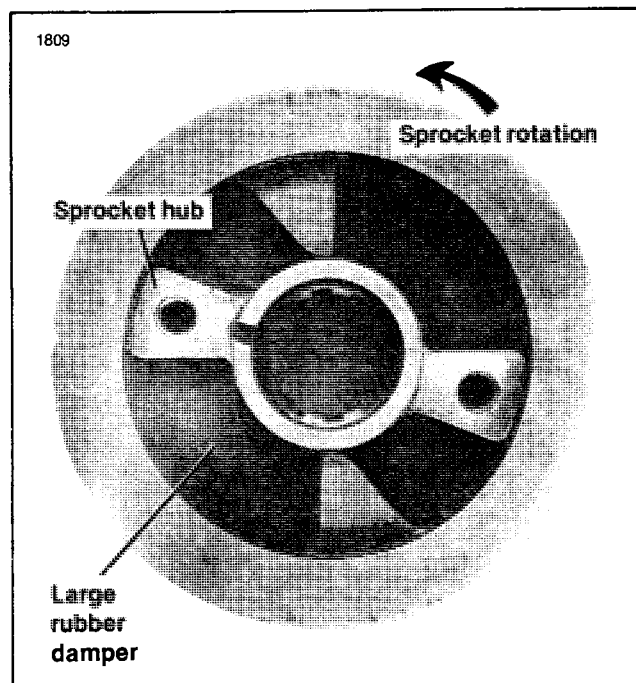
Figure 6-7 on page 6-6 of the 1978½ to 1981 FL/FX Service Manual may need some clarification. The exploded view drawing is correct as viewed with parts installed on the motorcycle. The photograph (1684) shows the sprocket rubber dampers and hub from the back side. Installed properly on the motorcycle, the sprocket, dampers and hub should look like Figure 1 when viewed from the left side of the motorcycle. This is important since the square surface of the sprocket projections must receive the load from the hub as transmitted through the large rubber dampers. If the sprocket and/or rubber dampers are reversed, excessive noise and/or parts wear may occur.

Figure 1. Correct Belt Drive Compensating Sprocket Assembly

When assembling the compensating sprocket, always check the clearance between the outer FLANGE BEARING, Part No. 40254-80, and the sprocket. If the clearance exceeds .0015 in., replace the flange bearing. Excessive clearance may lead to misalignment of the sprocket and excessive parts wear and noise.

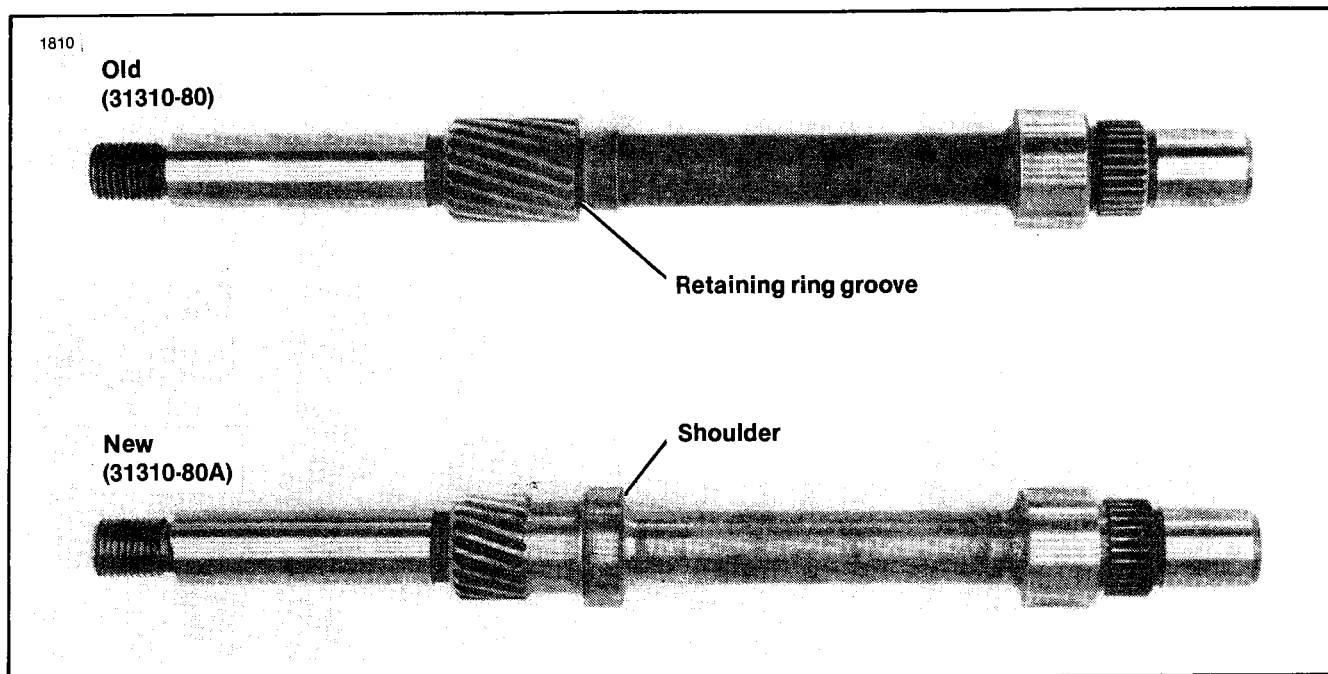
Starting with VIN 1HD1BDK12BY017428, all 1981 FXB models have a new style STARTER SHAFT, Part No. 31310-80A. This shaft has an added shoulder in place of

the retaining ring groove and RETAINING RING, Part No. 31313-80, as shown in Figure 2. The new shaft is a direct replacement for the old and should be used whenever replacing a starter shaft on 1980 or 1981 FXB models.

Figure 2. Old and New Style Starter Shafts
