SERVICE BULLETIN

M-846

December 4, 1981

POSITIVE BATTERY CABLE ROUTING 1982 FXR MODELS

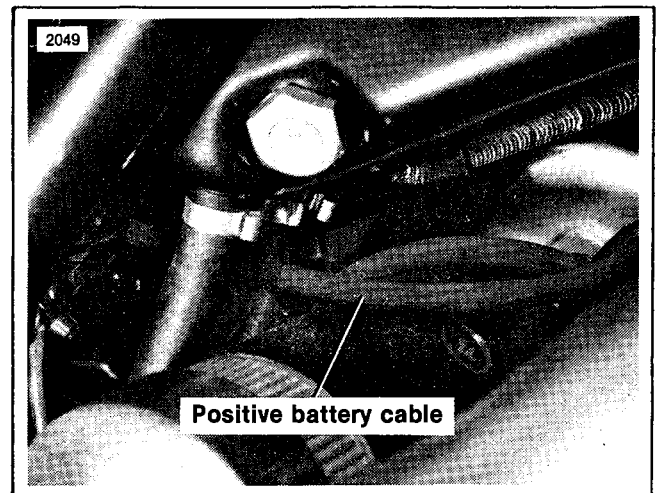
Figure 1. Correct Battery Cable Routing

The positive battery cable on 1982 vehicles prior to VIN 1HD1EAK12CY112496, may contact the bottom edge of the battery carrier. This surface could cause premature wear of the cable insulation resulting in an intermittent short circuit.

See Figure 1. Reroute the positive battery cable between the second and third oil hoses leading from the oil tank.
