## SERVICE BULLETIN

HARLEY-DAVIDSON

M-870 April 15, 1983

# NEW VALVE GUIDES FOR XL SERIES TRANSMISSION MAINSHAFT SHIMS IGNITION MODULE/SENSOR CONNECTORS

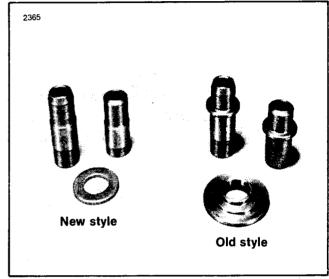
Figure 1. Valve Guides and Collars

New style intake and exhaust valve guides, Figure 1, are being incorporated on the XL series 1000cc engines, beginning with crankcase number 783. New flat lower spring collars and new longer inner and outer springs are also being included at the same time. The longer springs provide increased spring tension.

The new lower spring collars and new longer springs can only be used with the new style valve guides.

The new style valve guides will also be used for service replacement of old style guides on all XL series 1000cc engines, and will allow the use of all old valve train components, if desired.

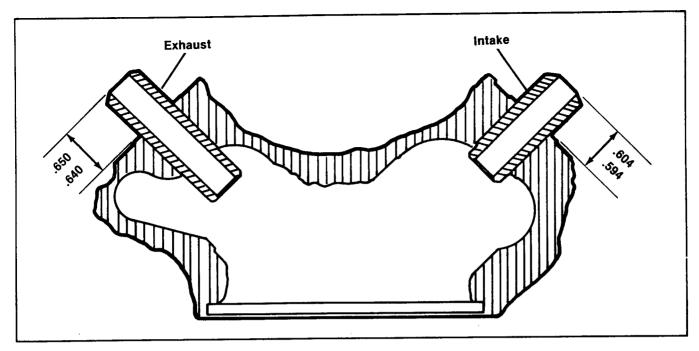
Figure 3. Valve Guide Projection

Because the new style valve guides do not have a shoulder, special VALVE GUIDE DRIVER HD-33871, Figure 2, must be used to control the guide installed height. See Figure 3.

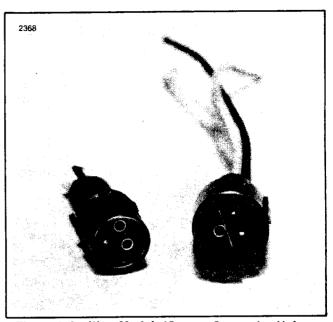
Figure 8. Ignition Module/Sensor Connector Halves

Late 1983 XL ignition modules Part No. 32410—84 and sensor assemblies Part No. 32400—80 are being manufactured with rubber rather than plastic connectors. This change is being made to improve component service life and to avoid possible separation of connectors in the field. When servicing early 1983 ignition systems, always check the module/sensor connectors for tight fit.

The late 1983 XL modules and sensors will interchange with the early 1983 XL modules and sensors, but will require replacement of the mating connector half if only one component is replaced. Rubber receptacles with 2 sockets and 1 pin or rubber plugs with 2 pins and 1 socket, (Figure 8) are available through Parts and Accessories.

When servicing early 1983 XL ignition system components, always replace the ty wrap used to secure the module and sensor plastic connector halves.
