# SERVICE BULLETIN

M-874

Sept. 23, 1983

## TOUR-PAK FASTENER

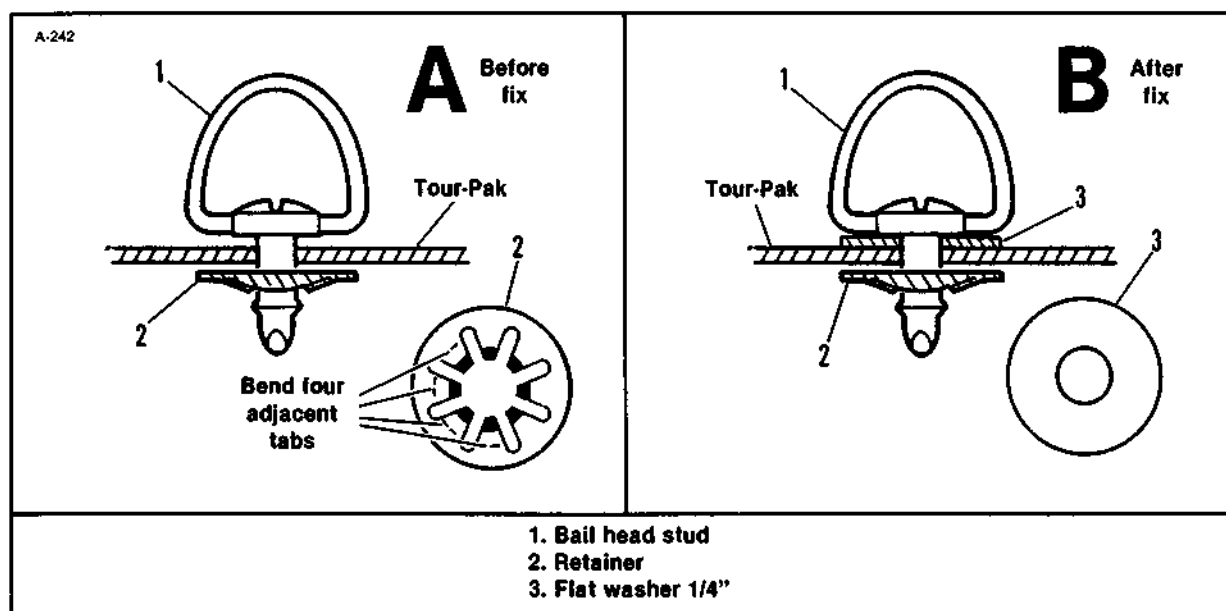
Figure 1. Flat Washer Installation

Earlier Tour-Pak installations did not have the reinforcement washer which increases retention of the stud in the receptacle detent. Tour-Paks that have quarter turn fasteners which do not hold the stud firmly in the receptacle can easily be fixed by adding a 1/4" flat washer beneath the head of the bail head stud.

1. With a pen knife or small screwdriver, bend four adjacent tabs on the retainer washer (2) to enlarge the inside opening. Retainer washer will now fall free.

2. Remove bail head stud (1).
3. Place an SAE standard 1/4" flat washer (3) over stud and reinsert stud through Tour-Pak hole.
4. With pliers, flatten tabs on retainer (2) closing the opening to original size.
5. Force retainer (2) flat side first, over shoulder of bail head stud (1) as shown in Figure 1.

*If there is any problem removing retainer, the part can be cut with a pair of side cutters and a new retainer installed. New retainers to replace those cut or damaged can be ordered under Part No. 90790-83.*
