# SERVICE BULLETIN

M-888

April 17, 1984

## 1340cc GENERAL SERVICE INFORMATION

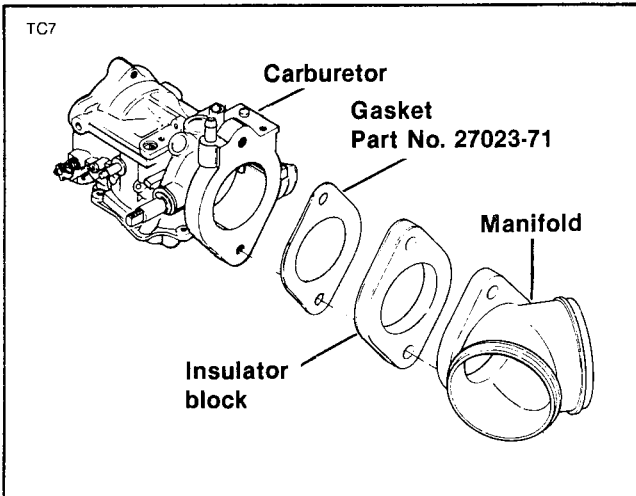
Figure 2. Gasket Location

A gasket (Sportster Part No. 27023-71) has been added between the carburetor and the insulator block on all 1340cc engines assembled in February, 1984 and the remainder of the 1984 model year. See Figure 2.

On earlier 1340's, if an air leak is found or suspected between the carburetor and insulator block, install the gasket.

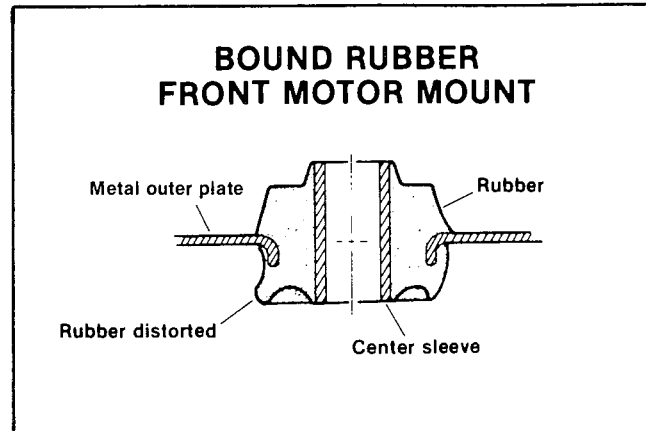
Figure 3. Misaligned Engine Mount

necessary because the mount functions as a damping spring. The smallest amount of preload can cause abnormal vibrations. If the mount is preloaded, the rubber will bulge, in one direction away from the outer metal plate. See Figure 3.

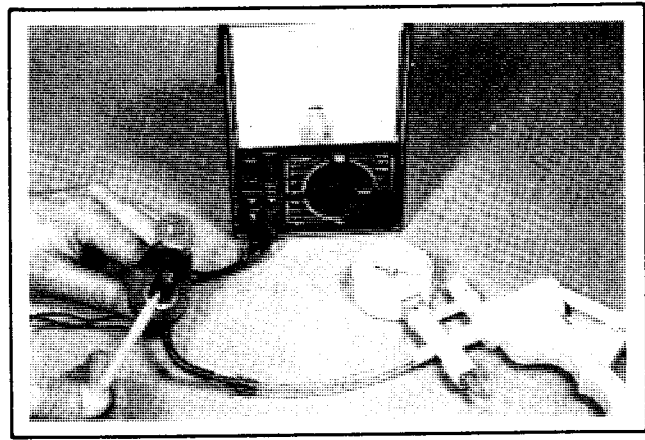
**Figure 7. Recalibrating V.O.E.S.**

If engine hesitation occurs at 2500 rpm and lower rpm, recalibrate or replace the V.O.E.S. as follows.

1. Remove vacuum hose and check the hose nipple. If the hose nipple has a red paint dab, this identifies the switch as Part No. 26555-84 and recalibration is not required. (You may wish to check that V.O.E.S. is actuating at the correct vacuum.)
2. If hose nipple is unmarked, remove the V.O.E.S. and scrape out the silicone sealer at the top of the switch.
3. See Figure 7. Connect an ohmmeter to the switch leads and attach VACUUM PUMP, Part No. HD-23738 to vacuum hose nipple.
4. Reset the adjusting screw so the switch closes at 5 in. Hg.

5. Reseal the adjusting screw hole with silicone sealant.
