SERVICE BULLETIN

M-911

October 8, 1985

JIFFY STAND CATCHES — XLH MODELS

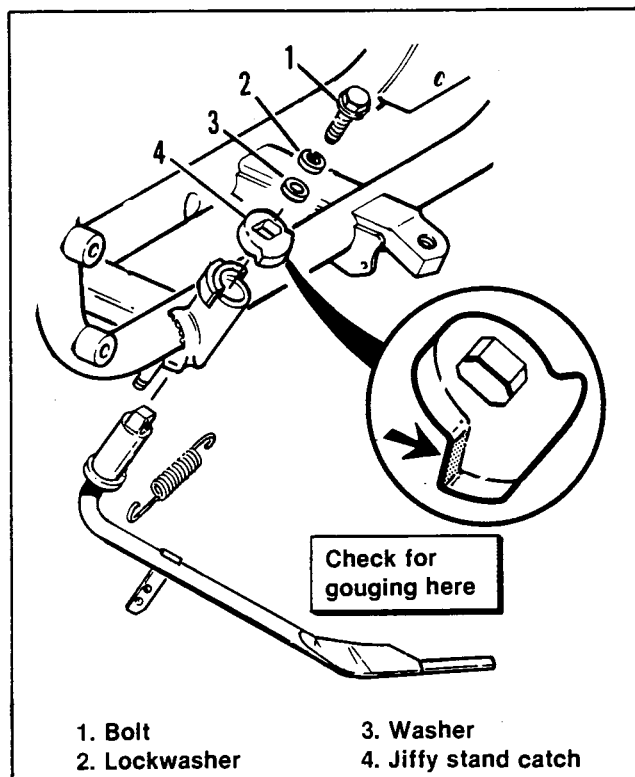
Figure 1. Jiffy Stand

Our records indicate that some 1986 XLH model motorcycles may have been assembled with "soft" jiffy stand catches. The "soft" metal condition may allow the square on the jiffy stand to rotate in the catch and allow the motorcycle to tip.

See Figure 1. Inspect all motorcycles at your dealership and those you have sold that are in the VIN range listed above for excessive lean angle while resting on jiffy stand. Also examine the leading edge on the catch that contacts the frame.

Any gouging or metal displacement at this location indicates the catch is soft and must be replaced. Order Harley-Davidson Part No. 50038-84.

1. See Figure 1. Support motorcycle and remove bolt (1), lockwasher (2) and washer (3).
2. Remove catch (4) and replace with properly hardened catch, Harley-Davidson Part No. 50038-84.
3. Install hardware removed in step 1 and tighten bolt (1) to 18-20 ft-lbs torque.
