SERVICE BULLETIN

M-925

March 25, 1986

HANDLEBAR SWITCHES

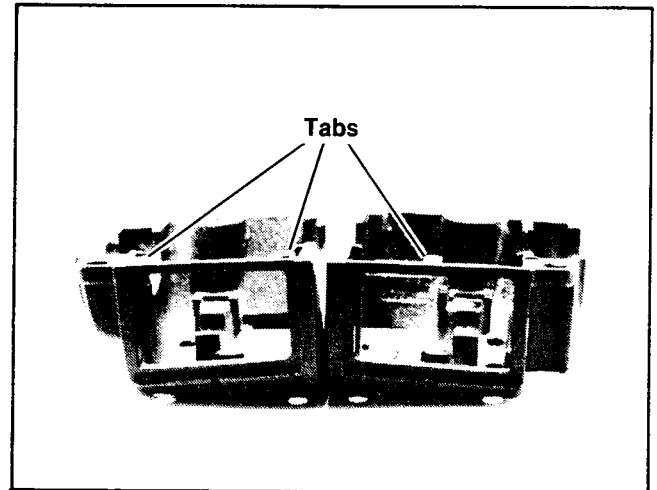
Figure 1. Handlebar Switch Housings

Refer to Figure 1. 1982 to 1985 handlebar switches had locating tabs, on one half of the switch housing, which fit into indents or slots in the mating half of the switch housing. Beginning with 1986 models, the housings no longer have the tabs or slots in the switch housing contact surfaces.

Stock switch housings for repair parts orders presently have the tabs. When fitting a switch housing, (parts order stock) that has the tabs, to a switch housing that no longer has the slots, (current production vehicles), it will be necessary to grind or file the tabs flush with the base surface prior to assembly.
