SERVICE BULLETIN

M-937

November 14, 1986

1987 CRANK PIN, PINION SHAFT & BEARINGS

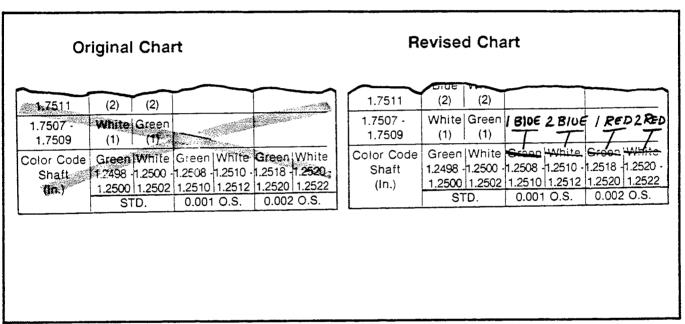
Figure 2. Pinion Shaft Bearing Chart Color Code Changes

See Pinion Shaft Bearing Chart. The pinion shaft color codes for oversized shafts have changed as follows:

0.001 in. O.S. - 1 or 2 Blue paint dot(s)

0.002 in. O.S. - 1 or 2 Red paint dot(s)

See Figure 2. Revise the chart and text to show this change.
