# SERVICE BULLETIN

M-938

## 1987 XLH IGNITION MODULES AND LEFT MAIN BEARING END-PLAY

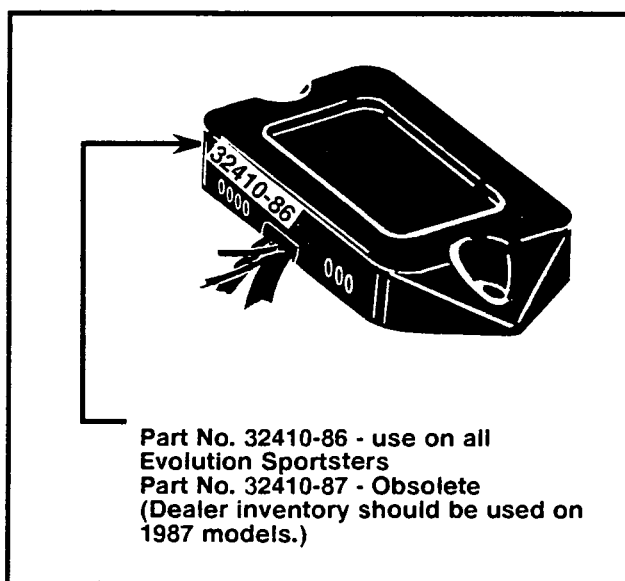
Figure 1. Ignition Module Identification

Testing at the factory has shown that the 1986 ignition module, Part No. 32410-86, provides performance equal to that provided by the 1987 ignition module. See Figure 1. Beginning with crankcase number 1787 314 005 on 883cc models and 1887 311 005 on 1100cc models, ignition module, Part No. 32410-86 is being installed at the factory. Part No. 32410-87 has been obsoleted. Dealers can service all XLH Evolution models by stocking only one module.

See Figure 1. The Part No. is stamped on the module as shown. Orders for the 32410-87 module will be filled with the 32410-86 module. Any 32410-87 modules in stock at your dealership should be used on 1987 models. PART NO. 32410-86 MODULES MAY BE USED ON ALL EVOLUTION XLH MODELS (1986 and 1987, 883cc and 1100cc).

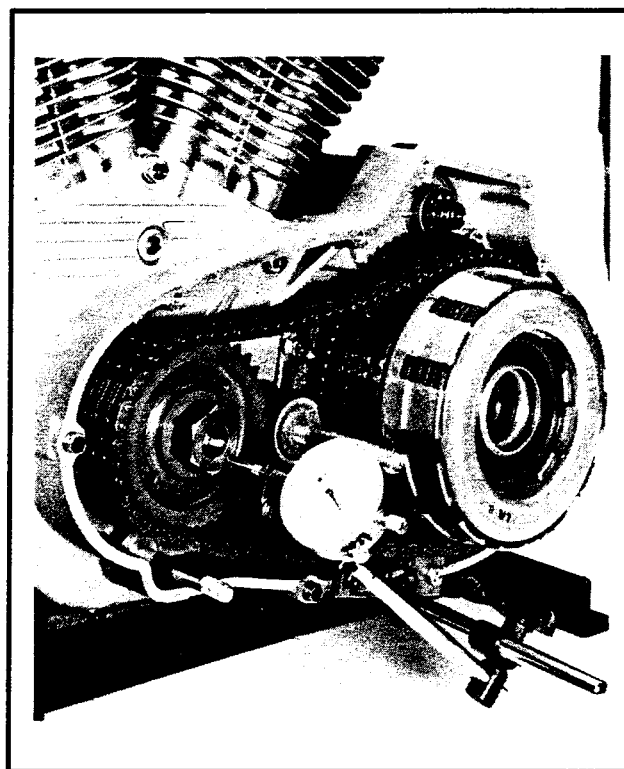
Figure 2. Checking Flywheel End-Play

1. See Figure 2. Secure a dial indicator to crankcase with indicator stem against sprocket shaft nut.

2. Rotate flywheels and at the same time, push and pull on the sprocket shaft. Read shaft travel on dial indicator. Shaft end-play should not exceed 0.007

in. If end-play exceeds maximum, sprocket shaft bearings should be inspected.

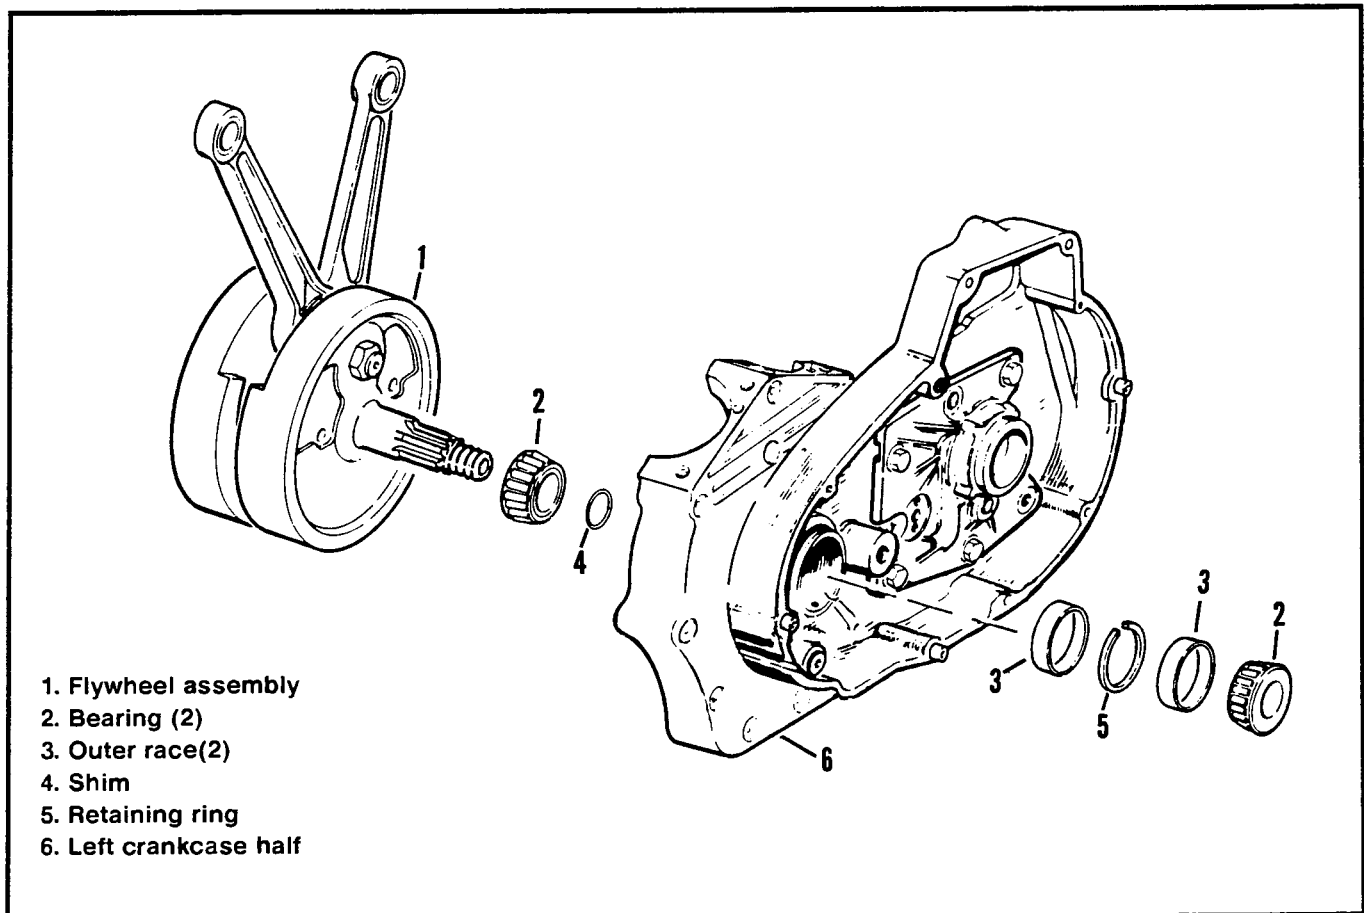
**Figure 3. Left Main Bearing**

3. See Figure 3. Disassemble crankcase following instructions in the appropriate XLH Service Manual. Inspect sprocket bearings (2) and races (3). If bearings and races are serviceable, measure thickness of shim (4). Install a thinner shim to reduce end-play or a thicker shim to increase end-play. See Table 1 for shim Part No. and available thicknesses.

4. If bearings or races must be replaced order Bearing Assembly, Part No. 24729-74. This assembly includes items (2 through 5) shown in Figure 3.
5. Install new bearing assembly and place shim contained with bearing assembly between bearings. Shim must be installed on sprocket shaft before left crankcase is assembled to flywheel assembly. Follow instructions in the appropriate XLH Service Manual.

6. Assemble crankcase halves following the appropriate XLH Service Manual procedures.
7. Recheck flywheel end-play. If end-play is not within 0.001-0.005 in., disassemble crankcase halves

and install the required shim, listed in Table 1, that will adjust end-play to 0.001-0.005 in.
