SERVICE BULLETIN

M-940

CHANGES FOR 1987 SOFTAIL VEHICLES

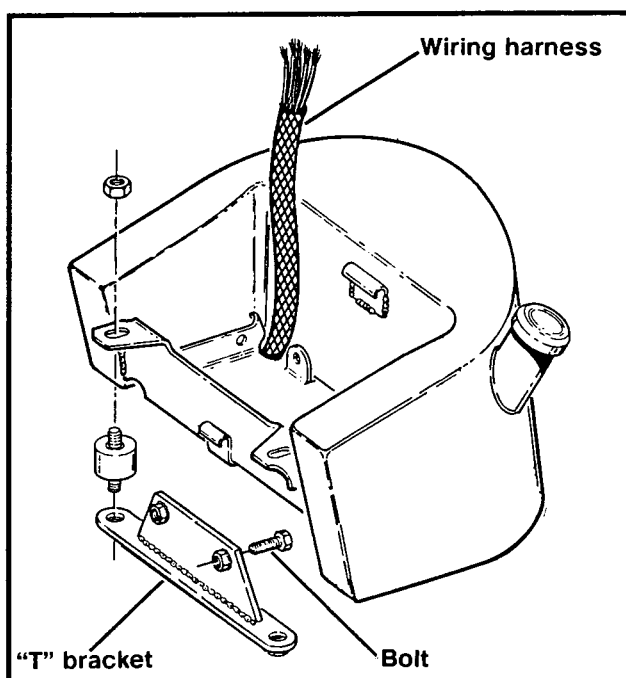
Figure 1. Harness Routing and "T" Bracket Bolt

Harley-Davidson has changed the routing of the frame seatpost wiring harness. It is now routed inside the oil tank.

See Figure 1. Some vehicles were assembled with the incorrect oil tank "T" bracket bolts. 3974H was used instead of 4391. 3974H is too long. Your customer may complain of a metallic "clunk" if the suspension bottoms. If this happens, remove the 3974H bolts and replace them with the 4391 bolts. Change the 1987 Parts Catalog to reflect this change.

See Figure 1. During routine maintenance, disconnect the wiring harness and re-route it inside the oil tank.
