SERVICE BULLETIN

M-949

JUNE 26, 1987

XLH TRANSMISSION CAM FOLLOWER

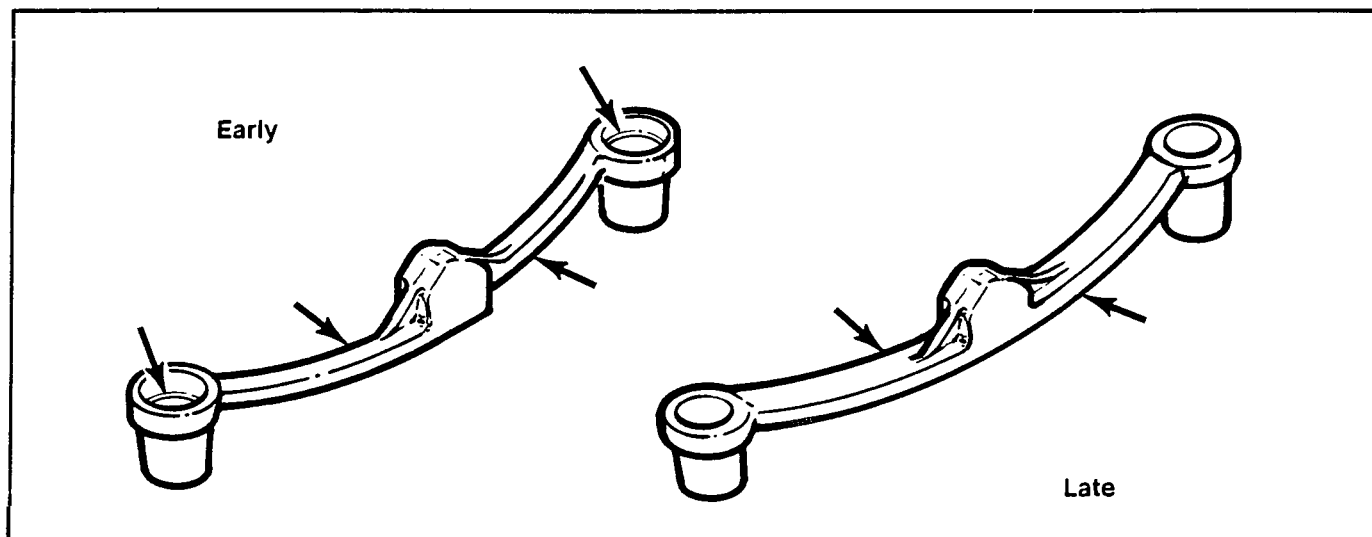
Figure 1. Early and Late Cam Followers

Early and late style cam followers are identified as follows, see figure 1;

Late style, Part No. 34063-84A.

1. Holes in cam followers are not counterbored.
2. Cam follower arms are not offset.
3. the cam follower is not magnetic.

Early style, Part No. 34063-84.

1. Holes in cam follower are counterbored.
2. Cam follower arms are offset.
3. the cam follower is magnetic.

Vehicles experiencing this problem should have the cam follower replaced with the early style, Part No. 34063-84. Instructions for replacing the cam follower can be found in the 1986-87 XLH Service Manual, Section 6.
