SERVICE BULLETIN

M-950

SPORTSTER OIL FILTER MOUNT

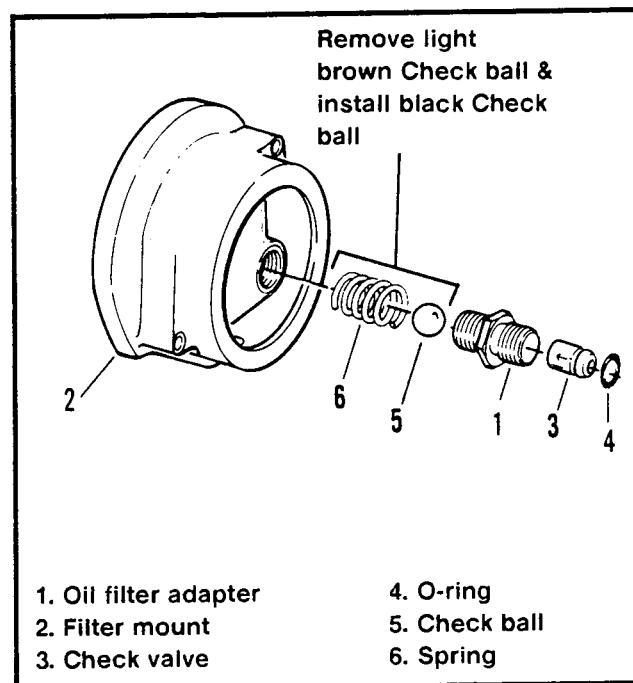
Figure 1. Either

The purpose of this bulletin is to advise technicians of a potential problem. Some Sportster oil filter mounts with the new oil check ball may have an undersize oil passageway. The check ball could stick causing reduced oil pressure.

See Figure 1. Remove the light brown check ball (5). Install new (black) check ball (5).
