# SERVICE BULLETIN

M-968

SEPTEMBER 2, 1988

## 1340 cc ONE PIECE FLYWHEEL-PINION SHAFT

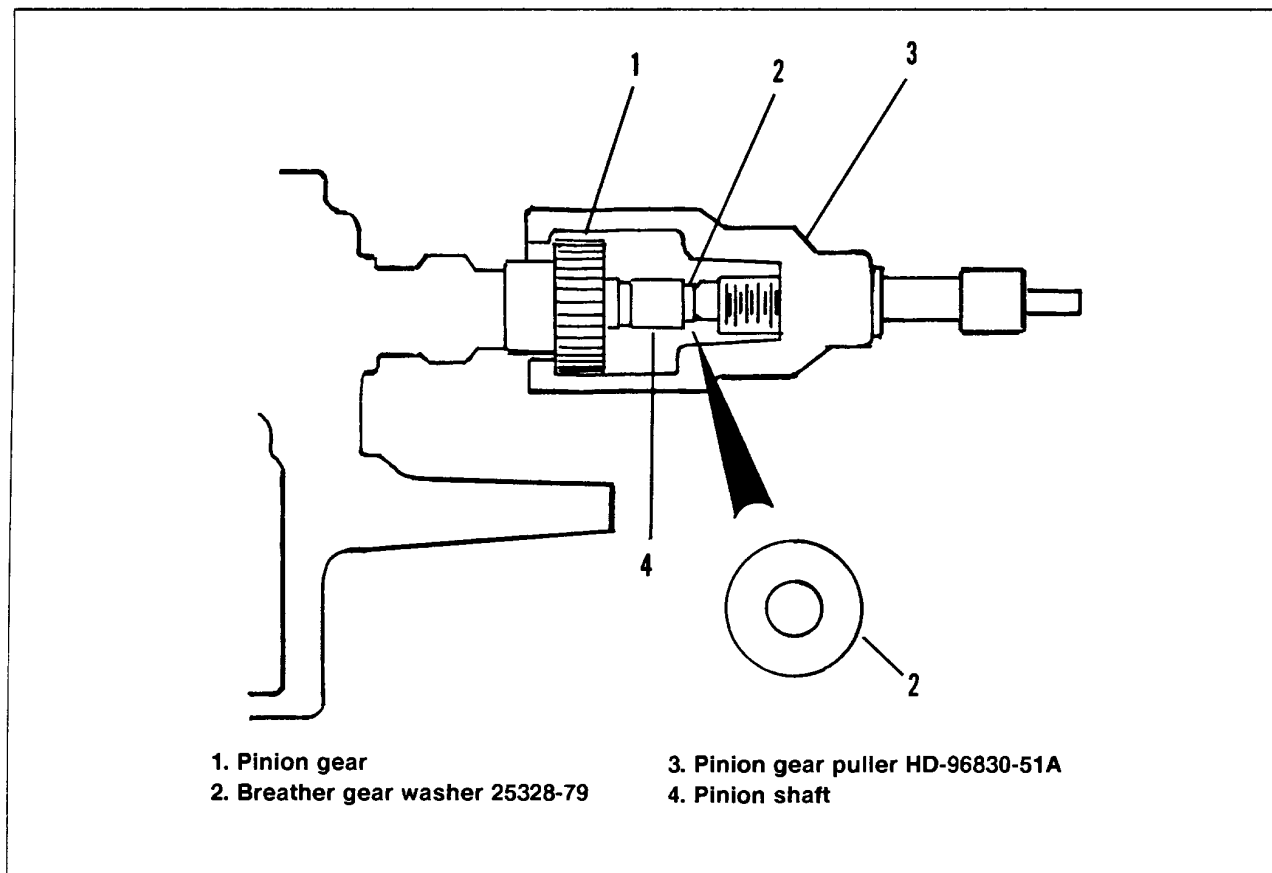
See Figure 1. Our immediate concern is any pulling operation which involves pressing against the end of the pinion shaft. An example is the removal of pinion gear (1). Due to the angle of the internal chamfer at the end of pinion shaft (4) there is concern that if the chamfered end of the spindle of tool (3), Part No. HD-96830-51A, were to be turned directly into the internal chamfer of pinion shaft (4) the end of the shaft may become slightly flared.

This slight distortion could prevent the shaft from fitting into the bearing of the gear cover.

Figure 1. Pulling Pinion Gear

To prevent any damage to the pinion shaft during removal, washer (2) Part No's 25320-79 thru 25328-79 must be positioned between the spindle of tool (3) and the end of pinion shaft (4). This washer is the steel breather gear washer used on vehicles 1979 to 1982. The breather gear washers came in various thicknesses, however, the thinner washers are preferable. The washer prevents the chamfered end of the spindle from entering the internal chamfer at the end of pinion shaft (4) eliminating any possibility of damage.
